## The Effect of Surface Defects on the Cyclic Fatigue Fracture of HEROShaper Ni-Ti rotary files in a Dynamic Model: A Fractographic Analysis

### ABSTRACT

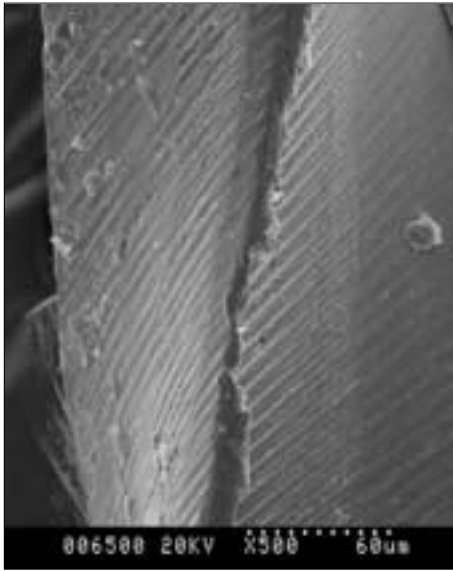
Microphotographs of the lateral surface of HEROShapers in group 2 showed metal rollover and/or significant machining marks along the faces of the flutes (Figure 2). In contrast, the lateral surfaces of the new HEROShaper files were rather clean and flawless. The low-magnification

**Figure 2.** Photomicrograph of a HEROShaper instrument in group 2 (before fatigue testing) showing the presence of manufacturing defects such as metal roll-over and machining marks (original magnification,  $\times 500$ ).

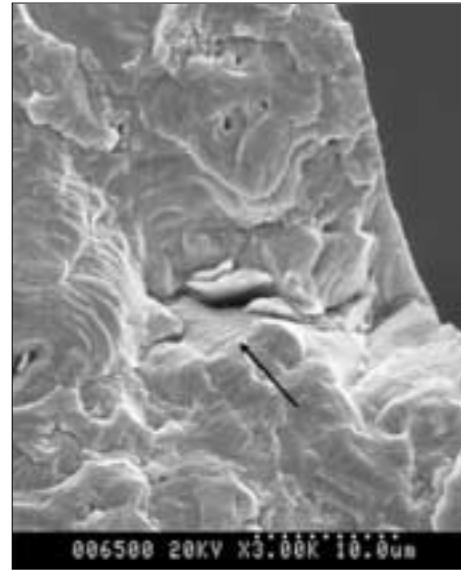
**Figure 3.** High magnification the SEM image of the brittle fracture region showing clusters of fatigue striations (arrows) as well as numerous secondary cracks (original magnification ( $\times 3000$ )).

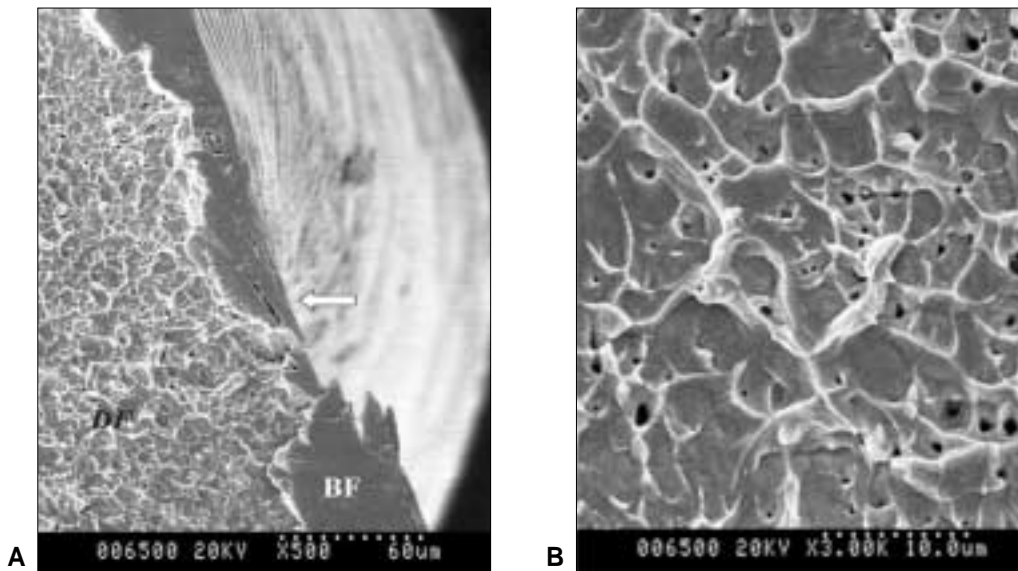
( $\times 200$  and  $\times 500$ ) SEM images show small areas of brittle fracture located on the edge of the cross section of the fractured instruments, which typically leads to a large central fibrous area of catastrophic ductile fracture. The higher magnification view ( $\times 3000$  and  $\times 10,000$ ) revealed clusters of fatigue striations and a large number of secondary cracks in the brittle fracture area (Figure 3), which confirmed that the instruments failed as a result of fatigue. Transgranular fracture across the grains as well as intergranular fracture along the grain boundaries was also observed in the brittle fracture area. The ductile fracture area was characterized by the typical formation of microvoids and the dimpling (cup-and-cone fracture), particularly elongated dimples in some specimens in group 3 (Figure 4a). All the fractured surfaces of HEROShapers in groups 2 and 3 were always consistent with the slow crack propagation (in a brittle fracture mode) from pre-existing surface defects (Figure 4b). Voids or regions of separation between some grains are also evident.

**Figure 4.** SEM image of the fractured surface of a HEROShaper instrument in Group 2. The brittle fracture (BF) region is shown originating from a microcrack. The brittle fracture region transforms to catastrophic ductile failure (DF) (a, original magnification,  $\times 200$ ). A high magnification view of the fractured surface of the same file shows elongated dimples (cup-and-cone fracture) that are indicative of ductile fracture. This characteristic feature of ductile failure results from microvoid coalescence as the instrument is subjected to stress (b, original magnification,  $\times 3000$ ).
