Images in Cardiovascular Medicine

Optical Coherence Tomography-guided Treatment of Multiple Stent Fracture in Patients with Overlapping Drug-eluting Stents

Jung-Hee Lee , MD, PhD and Ung Kim , MD, PhD

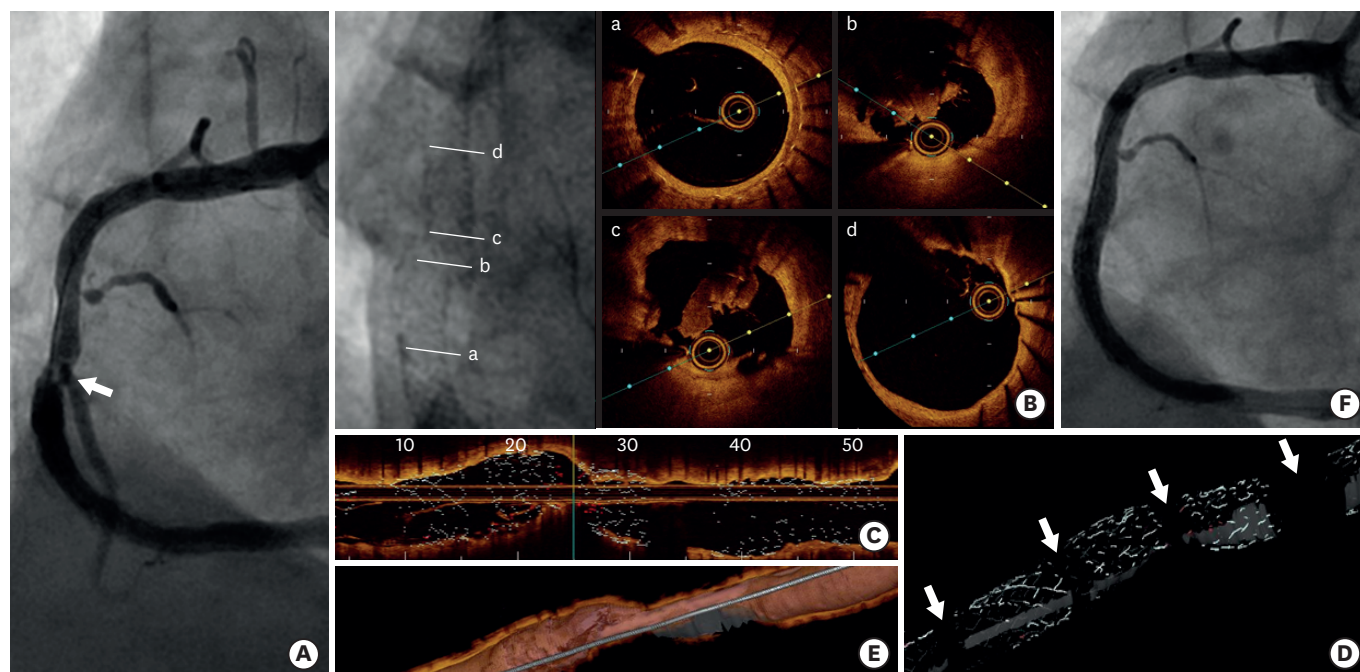
Multiple stent fracture after DES implantation is extremely rare, associated with a higher rate of adverse clinical outcomes.¹⁾ The risk factors of stent fracture are stenting in the RCA, longer and overlapped stents, hinge movement and vessel angulation; our case showed all these findings.^{2,3)} This case shows that the OCT-guided procedure easily identified multiple fracture, whereas conventional angiography could not.

Figure 1. (A) Coronary angiography shows intraluminal haziness (arrow) at the mid portion of the previous right coronary artery stent without significant in-stent restenosis. (B) Magnified fluoroscopic images showed suspicious complete separation with displacement of the previous drug-eluting stent overlapping site. (a-d) show each site of axial optical coherence images. (C) Longitudinal optical coherence tomographic images showed multiple stent fractures with 4 gaps. (D) 3D reconstructed stent strut images clearly demonstrated multiple stent fracture with 4 gaps (arrows). (E) 3D reconstructed images showed that the guide-wire was clearly inside the whole fractured stents. (F) After 4.0x18-mm Onyx (Medtronic, Minneapolis, MN, USA) implantation, the final angiogram revealed good distal flow without any residual stenosis or dissection. 3D = 3-dimensional.

A 71-year-old man presented with exertional angina. Ten years ago, he had undergone treatment for myocardial infarction with two heterogeneous drug-eluting stents (DESs) in the right coronary artery (RCA): 4.0×30-mm Endeavor™ (Medtronic, Minneapolis, MN, USA) and 3.5×32-mm Taxus™ (Boston Scientific, Natick, MA, USA). Coronary angiography revealed intraluminal haziness in the middle of the previous RCA stent without significant in-stent restenosis (**Figure 1A**). However, magnified fluoroscopic images showed suspicious complete separation with displacement of the DES overlapping site (**Figure 1B**). Optical coherence tomographic (OCT) images showed multiple stent fractures with four gaps, confirmed on 3-dimensional (3D) reconstructed strut images (**Figure 1C and D**). The first gap was located at the Taxus™, the second gap with displacement was at overlapping site, and the third / fourth gaps were at the Endeavor™. Cross-sectional OCT images revealed tight stenosis with false lumen at the stent displacement point (**Figure 1, a-d**); the minimal lumen area was 1.68 mm². Before percutaneous coronary intervention, the concern was guide-wire position, which might be out of the fractured stent. However, the OCT images showed that the guide-wire was located clearly within the fractured stents (**Figure 1E**). The distance between the first gap and the fourth gap was more than 35 mm, as confirmed by longitudinal OCT images (**Figure 1C**). However, the purpose of a newer stent implantation was not the whole coverage of the pervious stent fracture, but treatment of the tight stenosis at the stent displacement point. Therefore, the lesions including both fracture sites were treated with implantation of 4.0×18-mm Resolute Onyx™ (Medtronic, Minneapolis, MN, USA), corresponding to the length of the tight stenotic lesion. Unfortunately, we could not perform a post-stent OCT imaging because of the risk of contrast-induced nephropathy. However, the final angiogram revealed good distal flow without any residual stenosis or dissection (**Figure 1F**).
