Bilateral Fractures of Hydroflex Penile Prostheses : An Unusual Complication

We report bilaterally fractured Hydroflex implants in 2 patients. One fracture was complete and three were incomplete. All the fractures occurred at the junction of the rear reservoir and the inflation chamber.

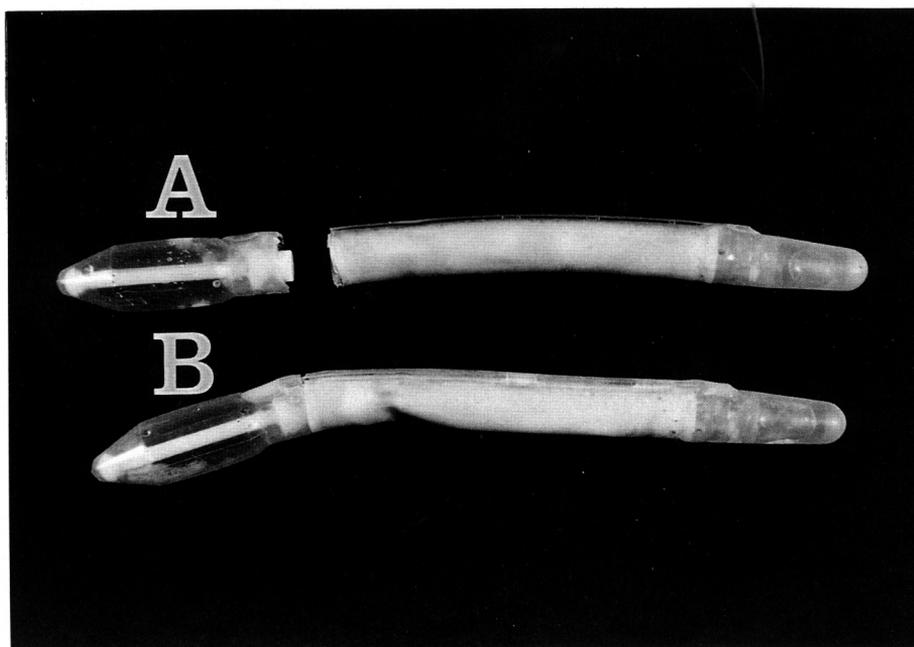
He was able to achieve coitus with the left side functioning normally, which also did not function after January 1994. He could palpate a break of the left implant just below the penile base. The patient denied trauma to the penis or abnormal use. Physical examination revealed a fracture of the left implant just below the penile shaft base. There was no local tenderness, swelling or erythema. On surgical exploration the left implant was found to be completely fractured and the right implant incompletely fractured at the junction of the rear reservoir and the inflation chamber (Fig. 1). They were replaced with two 1.1X16cm. Dynaflex implants.

Fig. 1. Case 1. A, completely fractured left side Hydroflex implant.
B, incompletely fractured right side Hydroflex implant.

populations. With respect to the other patient with paraplegia, occasional spreading of his thighs by force and unnatural posture with which he was carried on someone's back might be the cause of the fatigue tear.
