Considerations during crown reattachment procedure over the pulpal exposure: case report

However, in case of crown fracture with pin-point pulp exposure, we should cautiously minimize the irritation to the pulp and consider pre-treatment pulpal status, choice of pulp capping materials, choice of bonding system and treatment sequence during crown reattachment procedures. This case reports the considerations while crown reattachment with direct pulp capping using calcium hydroxide (Dycal, Dentsply Caulk). (*Restor Dent Endod* 2012;37(4):240-244)

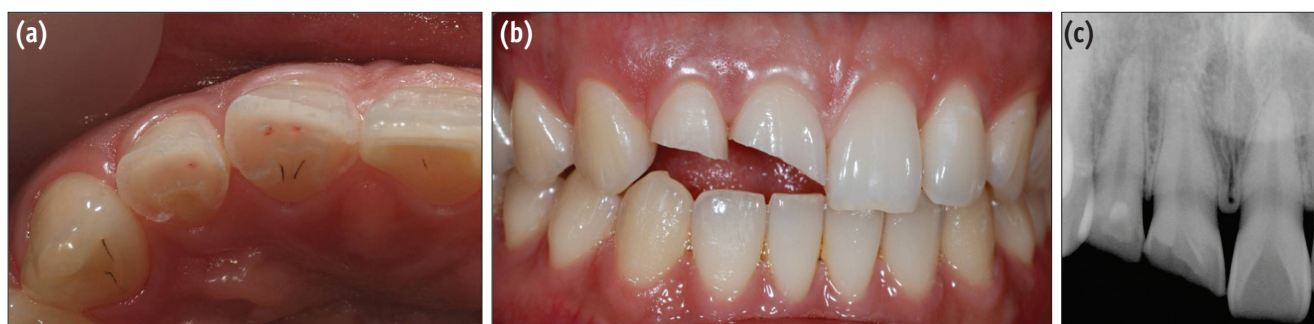
A 26-year-old woman visited the department of conservative dentistry because of crown fracture of the right central and lateral incisors after falling down in the bathroom twenty minutes before arriving at the dental office. The patient found tooth fragments and brought them stored in milk. Clinical and radiographic examination revealed that those two teeth were fractured supragingivally involving a pin-point exposure of the pulp (Figure 1). Because the pulp exposure size was minimal and exposure time was of short duration, crown fragment reattachment with direct pulp capping was planned.

Figure 1. Initial visit. (a) Intraoral photograph (palatal view). Pin-point pulp exposure was seen on tooth #11 and 12; (b) Intraoral photograph (Labial view); (c) Periapical radiograph.

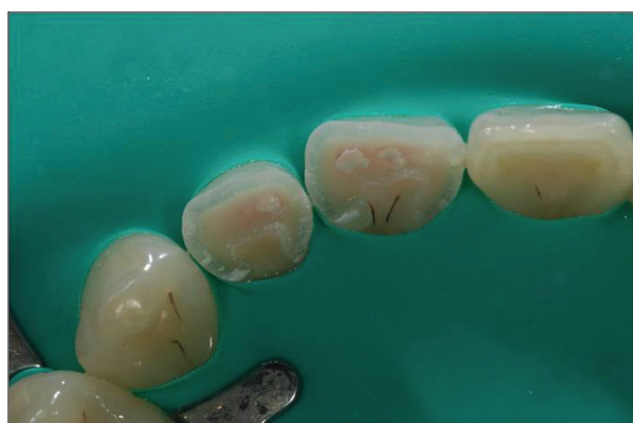
Figure 2. After acid etching, Dycal was applied.

with sterile cotton pellet in order to avoiding direct contact with acid. Enamel was etched with 35% phosphoric acid gel for 30 seconds.⁵ After rinsing and drying, the exposed pulp was capped with calcium hydroxide (Dycal, Dentsply Caulk, Milford, DE, USA) (Figure 2).

Then, etching procedure was done after Dycal setting in order to prevent pulpal damage from acid etching, we wonder if it is better. Burke and Watts reported that during an etching and washing cycle, Dycal lost 14.4% of its mass.¹⁰ The loss of material from Dycal as a result of acid contact is generally regarded as disadvantageous. Therefore, etching procedure should be done before Dycal application.

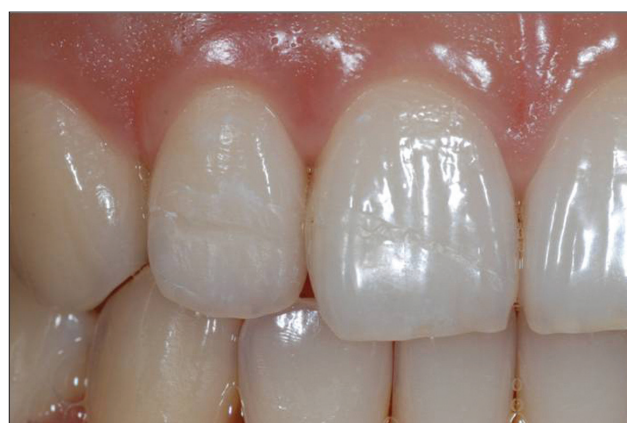
Figure 3. Labial view after the reattachment was done. The fracture line was visible, but the overcontouring was delayed to reduce the palpal damage.

Finally, timing of polishing should be considered. Conventionally, polishing and reinforcement of fracture line is done immediately after the fragment is rebonded in a single visit. However, Macedo and Ritter reported that delaying the overcontouring of fracture line is better to reduce the repeated pulpal damage in case of tooth treated by direct pulp capping because force and heat generated from preparation and polishing step may affect the pulpal status.⁸ Therefore, in this case, crown reattachment was done immediately but fracture line preparation, overcontouring and polishing steps were delayed 4 days after reattachment.

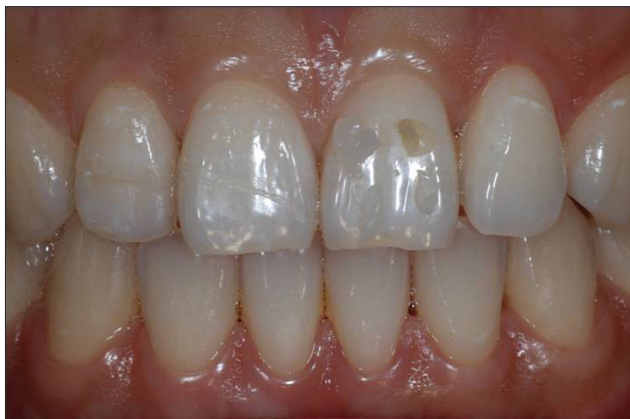
Figure 4. Shade selection was done from cervical and incisal area.

Four days later, fracture line reinforcement and polishing was done. After shade selection (Figure 4), preparation was placed on the buccal and palatal surface extending 2.5 mm coronally and apically from the fracture line with a depth of 0.3 mm (Figure 5). The area around fracture line was acid etched using 37% phosphoric acid (Figure 6). Then, adhesive was applied and light cured, followed by placement of resin composite to create slightly

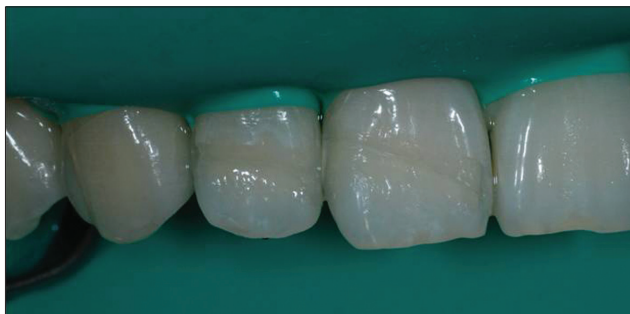
Figure 5. Fracture lines were prepared with 0.3 mm depth and 2.5 mm bevel in the incisal-cervical direction.

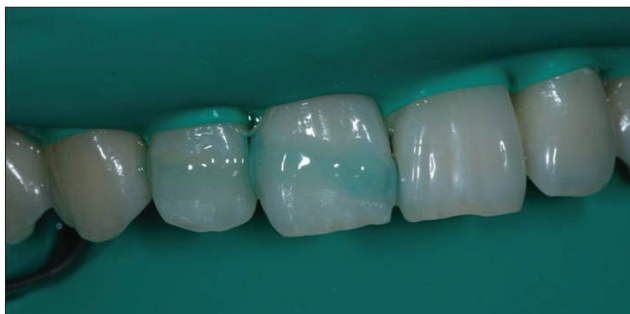
Figure 6. 37% Phosphoric acid was applied to the fracture line for 30 seconds.

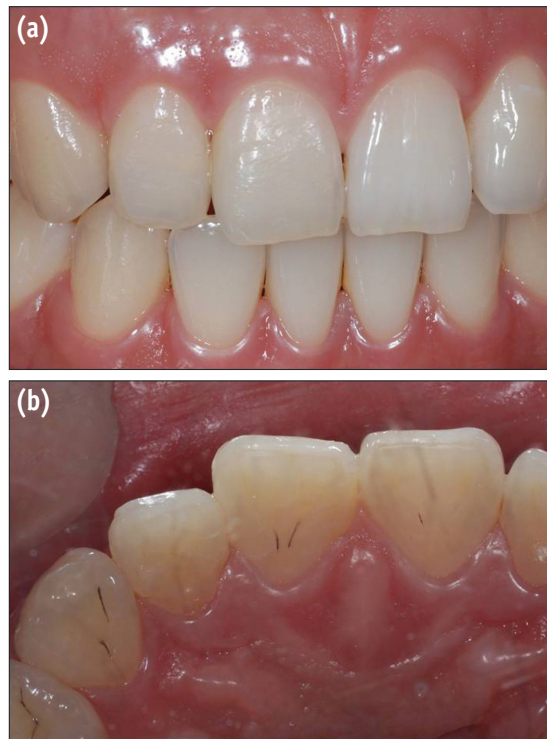
Figure 7. Composite was overcontoured and the excess was removed and polished. (a) Labial view; (b) Palatal view.

overcontoured surface. Excess composite resin was removed and polished (Figure 7). Periapical view showed no periodontal or periapical pathosis (Figure 8).

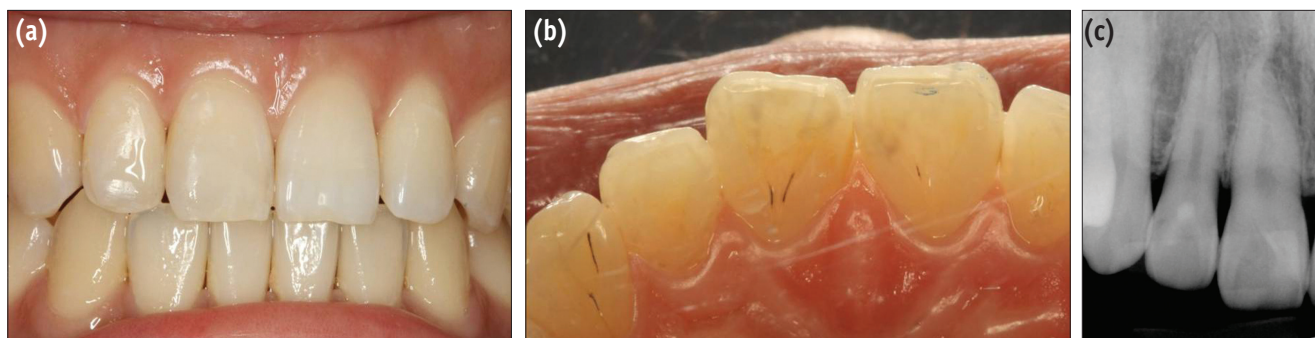
After 14 months, patient showed no clinical symptoms and the vitalities were well maintained. In addition, radiographic examination showed normal condition (Figure 9). The crowns were functionally and esthetically acceptable.

Figure 9. 14 months after the treatment. (a) Labial view; (b) Palatal view; (c) Periapical view. The teeth had normal pulp and apex and was esthetically acceptable.
