Delayed Rupture of Flexor Pollicis Longus after Volar Plating for a Distal Radius Fracture

Chul-Hyun Cho, MD, Kyung-Jae Lee, MD, Kwang-Soon Song, MD, Ki-Cheor Bae, MD

Department of Orthopaedic Surgery, Dongsan Medical Center, Keimyung University School of Medicine, Daegu, Korea

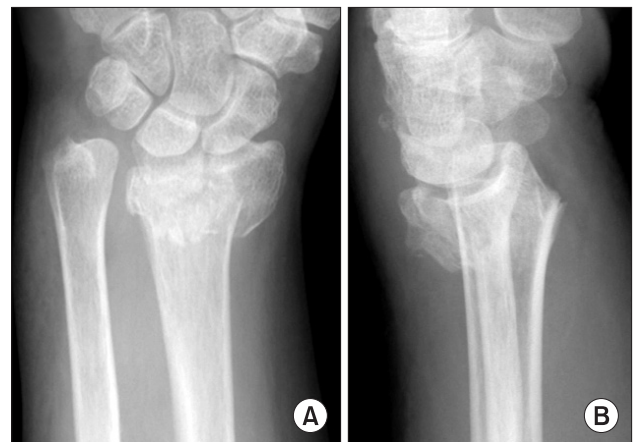
Fig. 1. Initial anteroposterior (A) and lateral (B) plain radiographs show the intra-articular comminuted distal radius fracture with dorsal displacement.

A 63-year-old right-handed woman sustained a right intra-articular comminuted distal radius fracture with dorsal displacement (Fig. 1), a right femoral shaft fracture, and a hemothorax in a motor vehicle accident. Open reduction and internal fixation was performed using 3.5-mm T-LCP for the distal radius fracture at 12 days after the trauma,

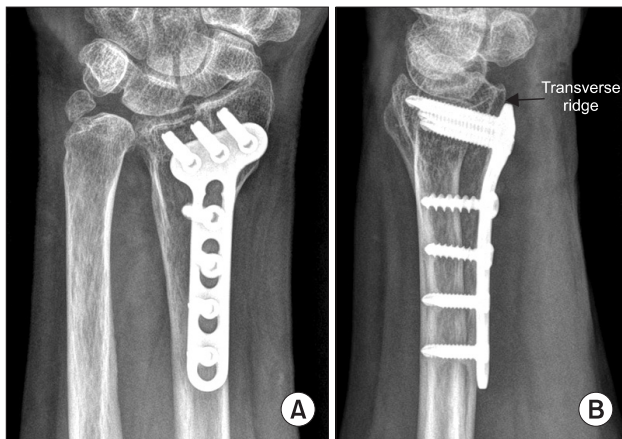
Fig. 2. Anteroposterior (A) and lateral (B) plain radiographs obtained at 40 months after surgery show no interval change in comparison with radiographs obtained immediately after surgery.

and the plate was covered by the pronator quadratus after fixation. Immediate postoperative plain radiographs revealed acceptable restoration of radial inclination, radial length, and volar tilting, except an approximate 2 mm step-off of the articular surface. The plate was placed tightly to the distal radius without any gap, and even though the distal edge of the plate was very close to the transverse ridge of the distal radius, it did not reach the distal portion of the transverse ridge. Plain radiographs at 8 months after surgery revealed bony union without further collapse of the distal fragment compared to that of the immediate postoperative radiographs, and range of motion of the right wrist was normal. Accordingly, we recommended plate removal, but the patient refused, stating that she was experiencing no specific discomfort.

In our case, there was no long-term use of steroids and the Synthes 3.5-mm T-LCP used was widely available and not custom-made. Additionally, no history of injury before surgery or of thumb abnormality after surgery were noted. Follow-up plain radiographs revealed bony union without further collapse of the distal fragment, as compared with radiographs obtained immediately after surgery. However, even though the plate was not violating the distal part of the transverse ridge, it was at the transverse ridge level. We found that the plate shaft was covered by the pronator quadratus, but that the distal edge was exposed. Additionally, the FPL tendon ruptured right at the point where it met the exposed distal edge. We suggest that the rupture was due to friction from the exposed distal edge of the plate at the transverse ridge, because the pronator quadratus does not attach to the distal part of the
