# Fracture of a Polyethylene Tibial Post in a Scorpio Posterior-Stabilized Knee Prosthesis

We report the case of a polyethylene tibial post fracture in a 72-year-old woman 14 months after a Scorpio posterior-stabilized (PS) total knee arthroplasty. The polyethylene wear was found around the fracture site of the post, especially over the anterior aspect of the post base. The failure mechanism of the post fracture in the present case was anterior impingement with excessive wear over the base of the anterior aspect of the tibial post, which became a stress-riser of post and cam articulation. This is the first report of a polyethylene tibial post fracture of a Scorpio prosthesis.

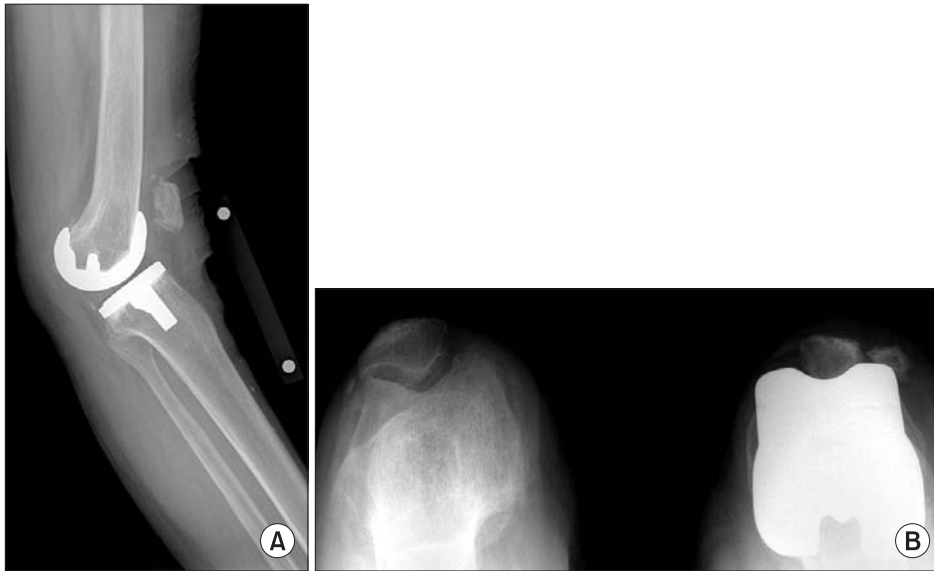
**Fig. 1.** Radiographs taken in the emergency department 14 months after total knee arthroplasty following slipping and falling. (A) Lateral radiograph showing genu recurvatum, (B) 45° Sky line view showing vertical fracture of the left patella.

In May 2006, 14 months after the TKA, the patient presented with painful swelling and an effusion of the left knee after slipping and falling. Radiographs showed a vertical fracture of the lateral aspect of the patella and genu recurvatum (Fig. 1). The patellar fracture was treated conservatively. Examination of her left knee revealed genu recurvatum and soft end points on varus and valgus stress testing. Soft tissue and ligamentous injuries were suspected. Magnetic resonance imaging (MRI) was obtained to evaluate an acute ligamentous injury. The MRI demonstrated a loose body fragment in the suprapatellar pouch (Fig. 2). Based on the shape and signal density, the loose body was believed to be a part of the post from the polyethylene tibial insert. Arthroscopy revealed a post fracture as the source of the loose body and a broken

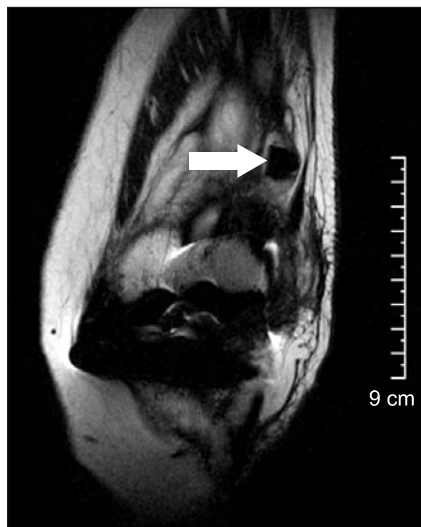
**Fig. 2.** Coronal fast-spin-echo magnetic resonance image of the left knee in a patient following a slip and fall revealed a loose body in the suprapatellar pouch of the knee consistent in shape with the tip of the tibial polyethylene post.

In the present case, a MRI was obtained to evaluate instability when the patient presented with painful swelling and an effusion of the left knee after slipping and falling. A retrospective review of the MRI demonstrated a loose body in the suprapatellar pouch of the knee consistent in shape with the tip of the post. We believe that a high index of suspicion and close scrutiny of low signal density of the tibial polyethylene insert may make the diagnosis possible with MRI.

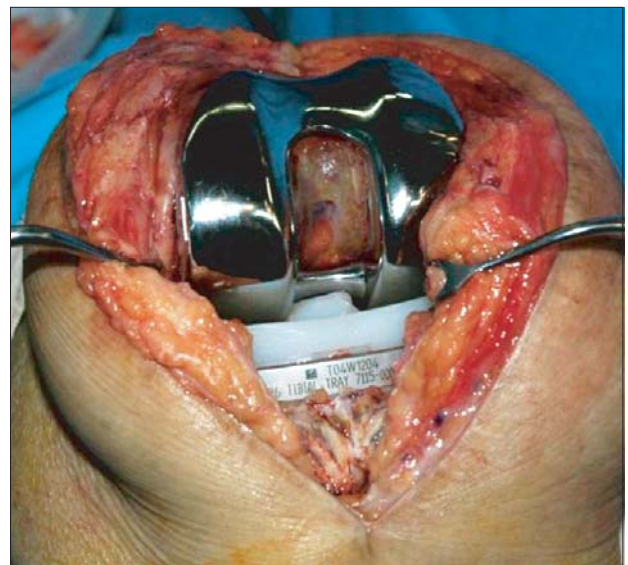
**Fig. 3.** Intraoperative photograph showing a fracture of the polyethylene tibial post at its base.

polyethylene fragment was found in the suprapatellar pouch. The tibial post was broken at its base with considerable wear of the anterior aspect (Figs. 3 and 4).

The failure mechanism of the post fracture in the present case was anterior impingement with excessive wear over the base of the anterior aspect of the tibial post, which became a stress-riser of post and cam articulation. When the lift-off force overcame the resistance of post integrity, the fracture occurred at the posterior base and propagated anteriorly.<sup>7)</sup> Our hypothesis is that weakness of thigh flexors due to the cerebrovascular accident caused genu

Revision of polyethylene tibial insert was performed 1 month after the arthroscopic procedure. Because the prosthesis appeared well-fixed and in good position, and there was no significant articular surface wear or asymmetry of the thickness of the two condyles, the broken polyethylene tibial insert alone was replaced with a thicker polyethylene tibial insert
