Late Onset Disassembly of a Modular Neck-stem Component after Cementless Hip Replacement without Dislocation: A Case Report and Review of Literatures

Key Words: Modular hip prostheses, Disassembly, Late onset, Neck-stem component, Dissociation

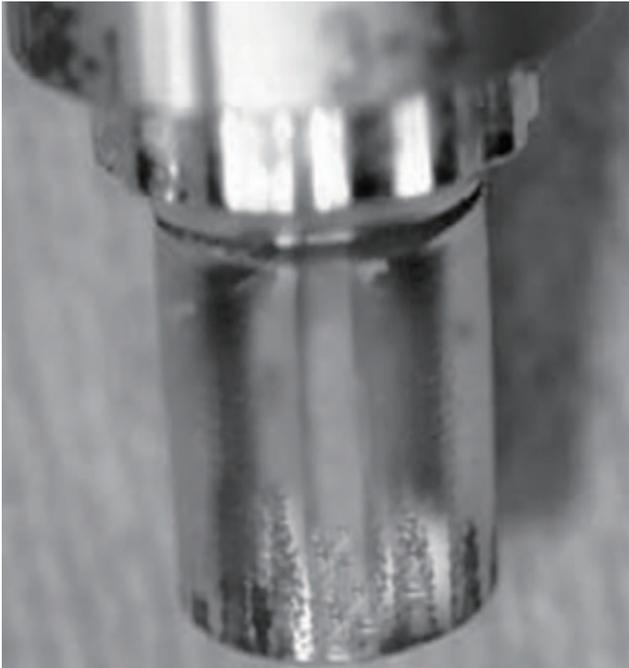
Fig. 2. Photo of the neck component demonstrates the corrosion.

In our case, several factors contributed to the disassembly of the neck-stem junction. A modular prosthesis was not a reasonable option for this obese female patient. The excessive load of the interface between stem and neck components increases the micro-movements to the junction and results in fretting corrosion, founded particularly at the neck of our case. It is likely that the patient in this study, in an attempt to sit on her couch, caused an excessive flexion in the hip and a possible impingement of the neck to the acetabular component. This impingement in addition to the increased micro motion to the junction due to the corrosion were possibly the main causes of this rare dissociation.

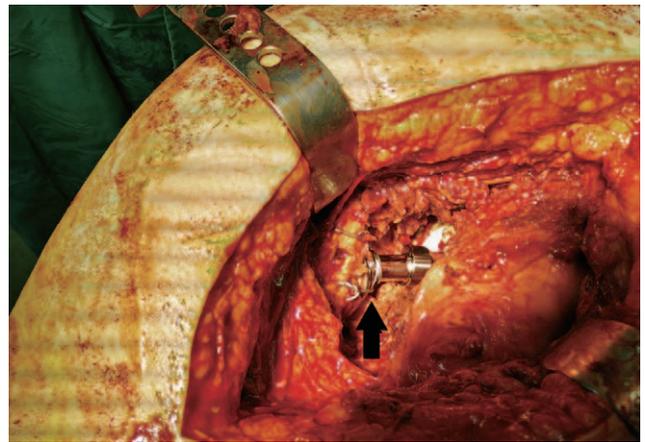
Fig. 3. Intraoperative image demonstrates the wiring application to the neck of the prostheses and the greater trochanter (black arrow).

based on her general physical condition, obesity, age, increased complications after stem revision and long-term rehabilitation she asked us not to revise her stem component. Based on the intraoperative findings of the stem taper junction wear and our patient preference we decided to maintain the stem component and we applied the wiring fixation to secure the junction.

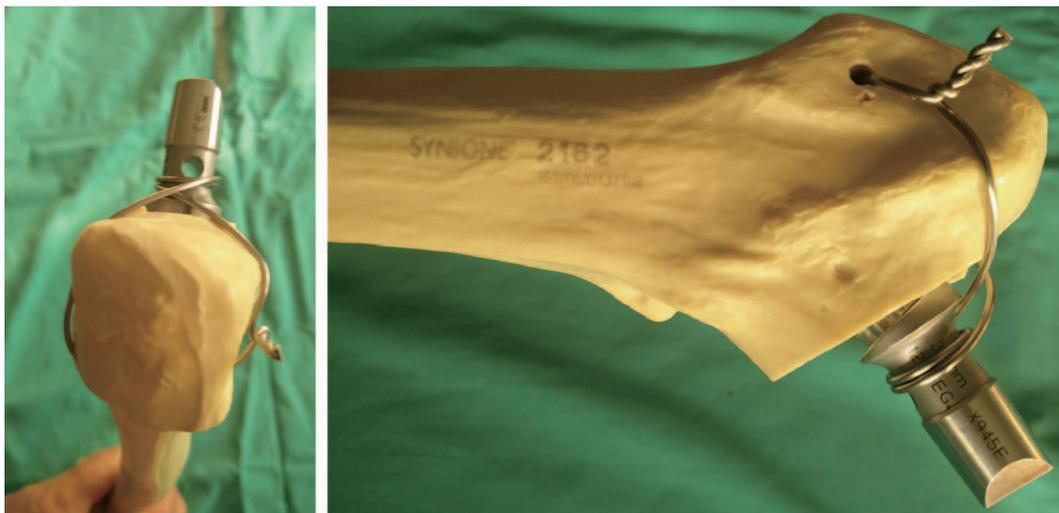
Fig. 4. Photo of a saw bone demonstrates the figure of eight fixation of the neck to the stem, by using the collar of the neck to secure the junction with the two loops of the wire.

We demonstrate our technique by providing a saw bone to highlight our method (Fig. 4). This is the first case that was treated with “figure of eight” wiring technique. However, this technique has been used in fixing intraoperative fractures of greater trochanter in total hip replacement procedures. The head-neck ratio couldn’t change because we maintain the acetabular component and the neck diameter is fixed. After reduction of the hip, the joint was stable and without impingement in the functional range of motion, while

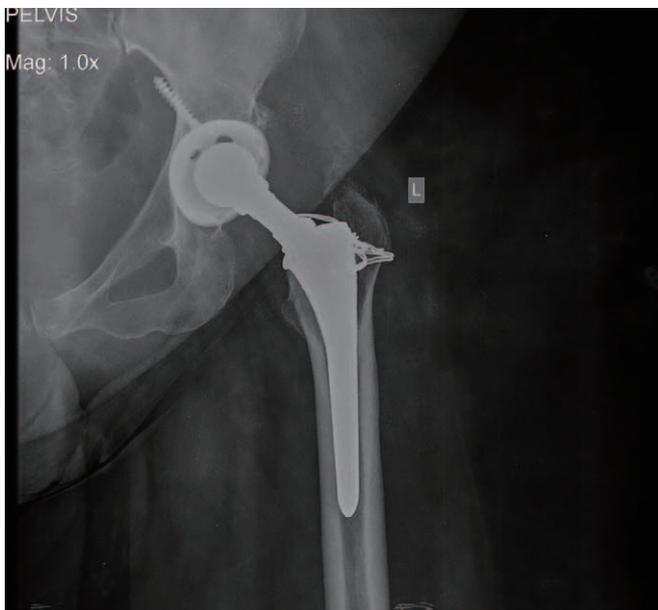
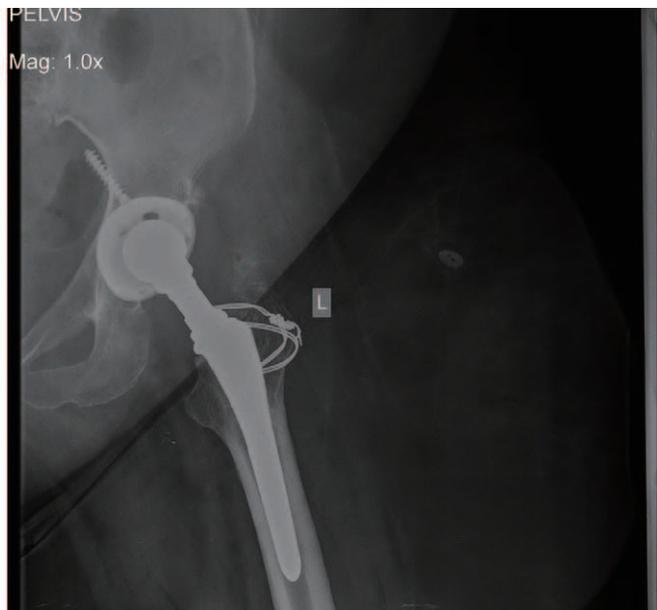
Fig. 6. Anteroposterior and profile hip radiogram 12 months postoperatively.

postoperative radiographic imaging was within normal limits (Fig. 5). The patient had an uneventful postoperative course with no other complications and returned to her daily routine 2.5 months after surgery. At the 12-month follow-up, the Harris Hip Score was 91 and the radiographic control was excellent (Fig. 6). Whether or not to revise the stem component was preoperatively discussed with our patient. We explained that revision of stem and neck components is the best treatment choice for this late onset dissociation, particularly if corrosion was the main cause. Furthermore, we analyzed in detail the revision procedure of this well-fixed stem, the possible complications and the prolonged non-weightbearing period. Our patient understood thoroughly the increased risk of a new dissociation due to stem taper corrosion, although
