In vitro evaluation of fracture strength of zirconia restoration veneered with various ceramic materials

PURPOSE. Fracture of the veneering material of zirconia restorations frequently occurs in clinical situations. The purpose of this *in vitro* study was to compare the fracture strengths of zirconia crowns veneered with various ceramic materials by various techniques. **MATERIALS AND METHODS.** A 1.2 mm, 360° chamfer preparation and occlusal reduction of 2 mm were performed on a first mandibular molar, and 45 model dies were fabricated in a titanium alloy by CAD/CAM system. Forty-five zirconia copings were fabricated and divided into three groups. In the first group (LT) zirconia copings were veneered with feldspathic porcelain by the layering technique. In the second group (HT) the glass ceramic was heat-pressed on the zirconia coping, and for the third group (ST) a CAD/CAM-fabricated high-strength anatomically shaped veneering cap was sintered onto the zirconia coping. All crowns were cemented onto their titanium dies with Rely X™ Unicem (3M ESPE) and loaded with a universal testing machine (Instron 5583) until failure. The mean fracture values were compared by an one-way ANOV

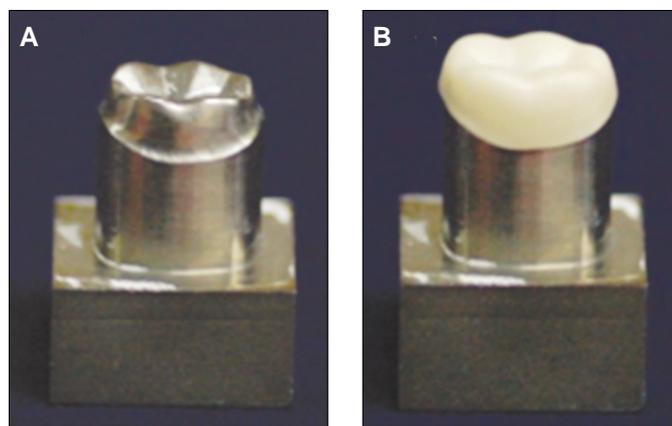
Fig. 1. Titanium die (A) and zirconia coping (B) during CAD/CAM fabrication process.

Additionally, the preparation was completed with a surveyor (F1, DeguDent GmbH, Hanau, Germany) using a carbide bur (Komet H 356 RGE 103.031, Gebr. Brasseler, Lemgo, Germany), to ensure that the preparation had an 8° tapered angle. Forty-five model dies were fabricated in a titanium alloy by CAD/CAM system (Myplant™, RaphaBio, Seoul, Korea) in order to duplicate the prepared stone model. To ensure the correct preparation angle, all 45 titanium master dies were finished with the surveyor using a carbide bur. A master die was scanned and 45 zirconia copings were manufactured by a CAD/CAM system (Lava™, 3M ESPE, Seefeld, Germany) using pre-sintered zirconia (Lava Frame™ Crown & Bridge, 3M ESPE, Seefeld, Germany). A wall thickness of 0.5 mm and a virtual spacer layer of 10 μm were chosen. After the milling procedure the enlarged copings were removed from the CAM machine and final sintering was performed in a special sintering furnace. The copings were examined for deformation and debris, corrected if necessary and cleaned with steam. Each coping was seated on a definitive die. Copings were rejected if the margin was rated visually unacceptable by two investigators (one dental technician and one dentist). Undercontoured frameworks and frameworks which could be rotated on the definitive die under finger pressure were also rejected. New copings were fabricated on the same dies to replace the rejected specimens. Forty-five acceptable copings were achieved from a total of 48 copings. Next, the acceptable copings were adapted until the best possible fit was achieved. The adaptation was made by an experienced dental technician with a magnification of eight (Stemi DV 4, Zeiss, Barrington, NJ, USA) according to the literature.²³ The sample of 45 copings was divided into three groups so that for each of the 15 testing models one adapted coping existed (Fig. 1).

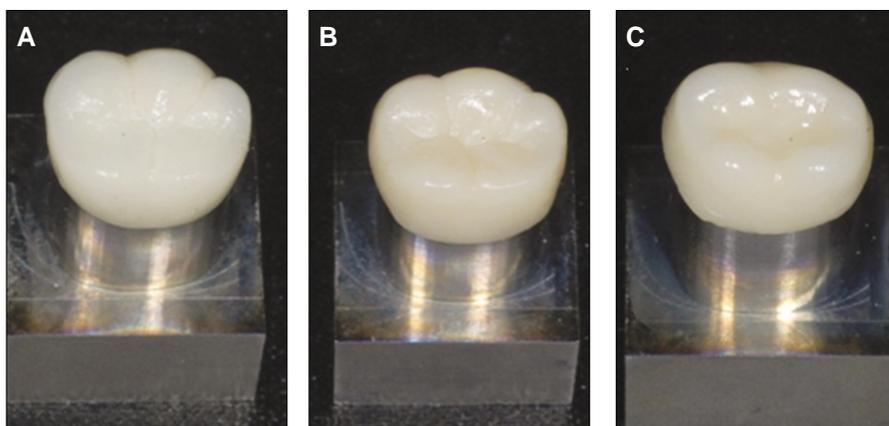
Fig. 2. Schematic design of three specimens after veneering process. A: Group LT, B: Group HT, C: Group ST.

The first step using the sintering technique to produce comparable test specimens within the scope of this study, was to generate glass ceramic veneer caps which fitted onto the zirconia copings on one side and correspond almost exactly to the outer shape of the crowns fabricated by the other two techniques applied for Groups LT and HT. The objective to acquire an exact copy of the veneered restorations from group LT by CAD/CAM technologies was easily achieved. The copings of Group ST and the outer surfaces of crowns from Group LT were dimmed by applying a contrast spray (Dentaco, Bad Homburg, Germany). Each coping of group ST was scanned by a white-light scanner (Lava™ Scan, 3M ESPE, Seefeld, Germany) and treated like a prepared tooth, additionally the outer surface of each crown from Group LT was scanned. The CAD/CAM system used (Lava™ DVS Digital Veneering System, 3M ESPE, Seefeld, Germany) provided the function of a double scan. So the outer and the inner shape could be scanned, matched together and the CAD/CAM system permitted the manufacture of the space between both scans from a material of choice. Lava glass ceramic blocks are available for the CAD/CAM-system used. This ceramic is ideally suitable for the sinter bond technique with zirconia copings due to the appropriate match of the coefficients of thermal expansion. The internal dimensions of the veneer cap correspond to the external dimensions of the coping. A joining gap should be available on the internal aspect of the veneer cap to join the two components. The external dimension of the veneer cap corresponds to the shape of the full anatomical crown (Fig. 2).

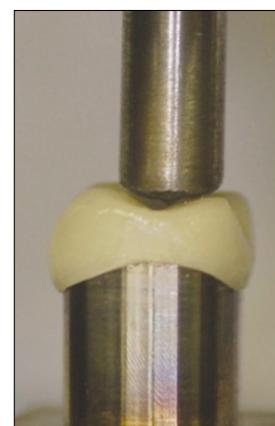
Fig. 3. Testing setup in the universal testing machine and position of load tip of test specimen and piston.

All crowns were put into the universal testing machine (Instron 5583, Instron, Norwood, MA, USA) at a 15° inclination relative to the long-axis and finally loaded until fracture occurred. Before the load was applied, the specimens were adjusted to the piston to ensure a three point contact between the stainless steel ball and the occlusal surface (Fig. 3). The load was applied with a 6 mm diameter stainless steel ball placed on the occlusal surface of the crowns and a crosshead speed

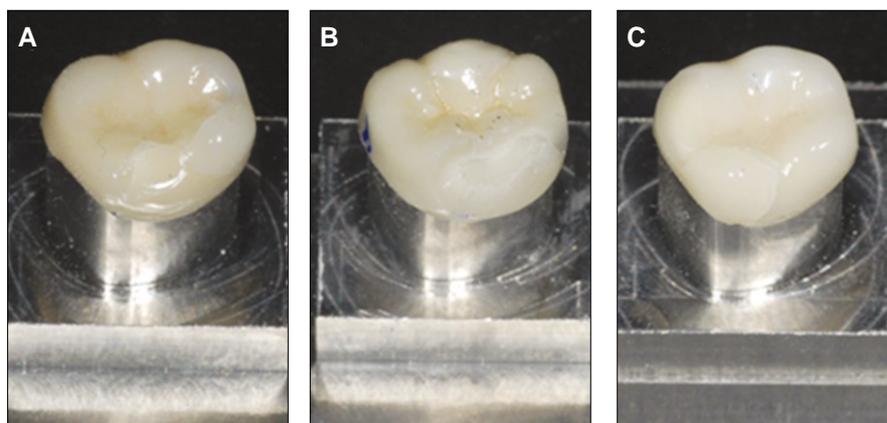
Fig. 4. Cohesive fracture modes of a specimen from experimental groups. A: Group LT, B: Group HT, C: Group ST.

The mean and standard deviation of fracture strength values for the three experimental groups are shown in Table 1. Two failure types were observed: total fracture, through both core and veneer and partial fracture through the veneer only (chipping). Total fractures were more frequent in the Group ST (eight) while five total fractures occurred in the Group HT and two total fractures were observed in Group LT. In all instances of partial fracture, the fracture was cohesive within the veneer material (Fig. 4). Crowns fabricated with the sintering technique

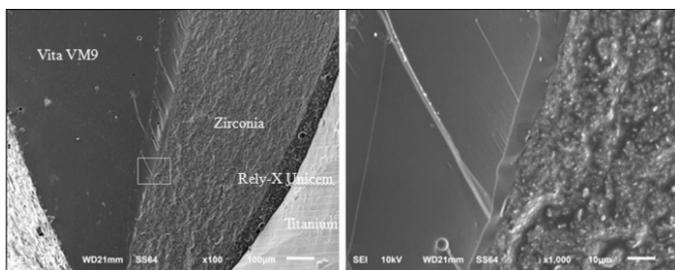
Fig. 5. SEM views of the interface between zirconia coping and veneering ceramics of Group LT.

(ST) showed significantly higher fracture strengths compared to crowns made with layering technique (LT) and heat pressing technique (HT) (Table 2). The Student-Newman-Keuls test indicated two subgroups, which exhibited statistically significant differences (Table 3). Scanning electron microscope (SEM) pictures have shown interfacial bonding conditions between the connector materials, internal coping materials and external veneering materials (Figs. 5-7).

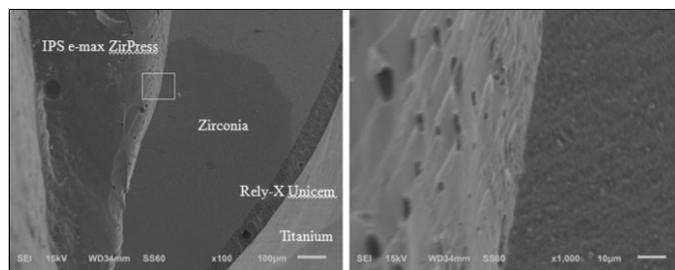
Fig. 6. SEM views of the interface between zirconia coping and veneering ceramics of Group HT.

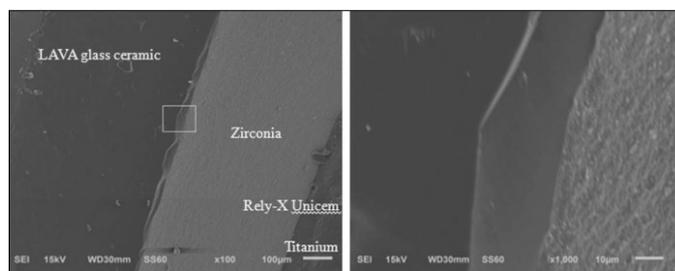
Fig. 7. SEM views of the interface between zirconia coping and veneering ceramics of Group ST.
