Repeated Ceramic Head Fracture after Ceramic-on-ceramic Total Hip Arthroplasty

Myung-Sik Park, MD, Sun-Jung Yoon, MD, Myung-Jae Yoo, MD

Department of Orthopedic Surgery, Research Institute of Clinical Medicine,
Chonbuk National University Hospital, Jeonju, Korea

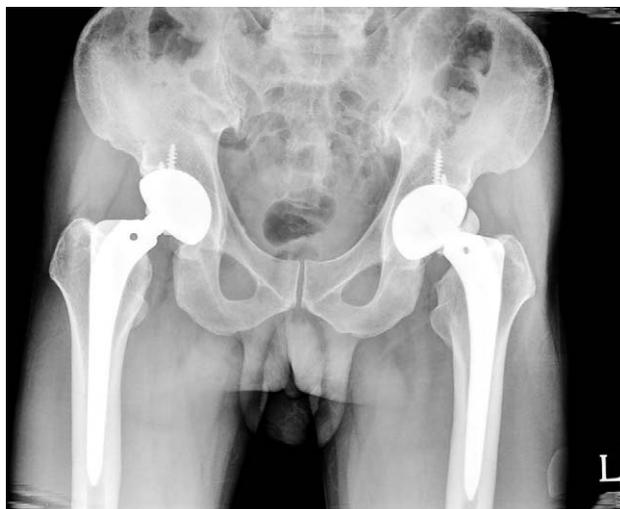
Fig. 1. Ceramic head fracture in the left hip.

fracture was observed on the left side of the ceramic head (Fig. 1). Computed tomography showed an intact liner and broken femoral head in the liner (Fig. 2). Intraoperatively, we observed that the trunion of the femoral stem was not grossly damaged at revision surgery and had a near normal contour. We removed ceramic particular debris carefully and exchanged the head and liner with and a new liner and 28 mm medium neck because of provide stability to the surrounding muscles. The patient followed an uneventful postoperative course (Fig. 3).

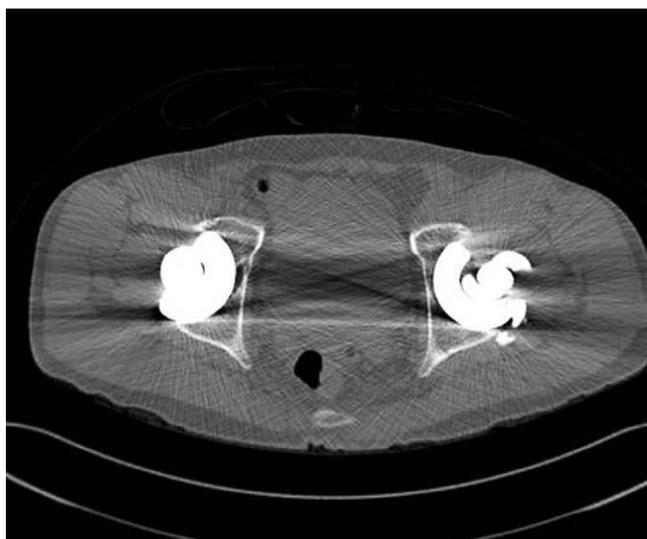
Fig. 2. Computed tomograph showing ceramic head fracture fragments were retained by the metal shell.

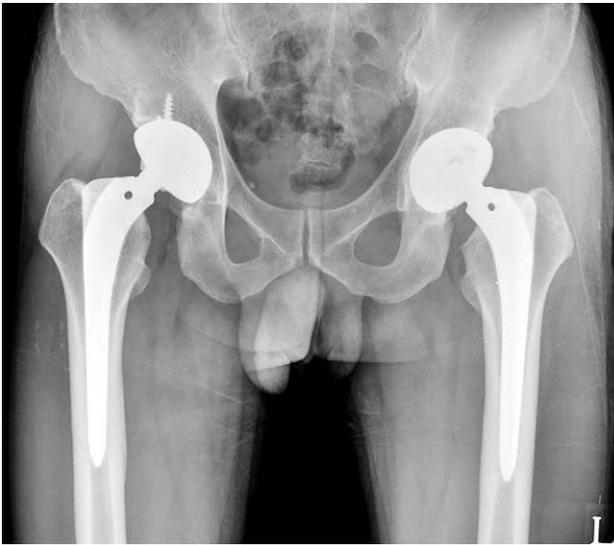
Fig. 3. A new ceramic head and liner were inserted.

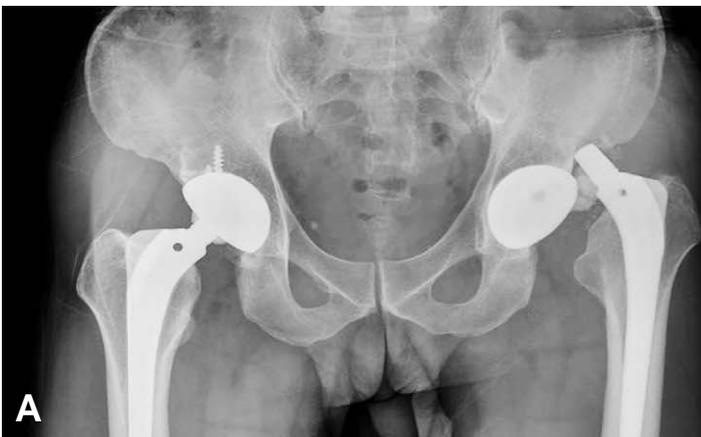
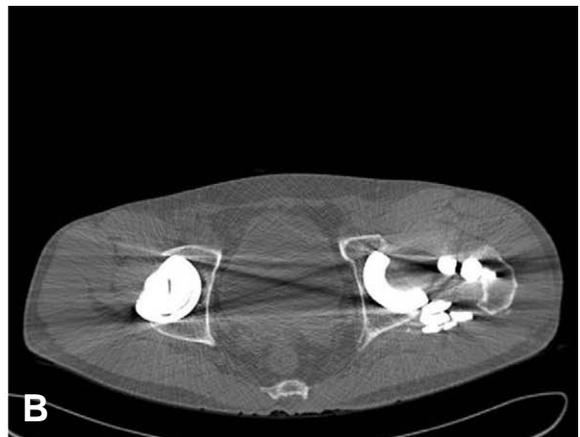
the emergency room, we took radiographs of both hips (Fig. 4A). The stem and acetabular cup were still well fixed, but the left side of the ceramic head was fractured and dislocated. Computerized tomographic (CT) scans of both hips revealed metal shells with a normal abduction angle range of 46.14° , but anteversion of the left metal shell was found to be 36.09° (Fig. 4B).

Fig. 4. (A) Second fracture of the ceramic head with dislocation and (B) cross sectional computed tomograph showing excessive anteversion of the metal shell and femoral stem.

In terms of operation-associated factors, Barrack et al.¹⁾ showed that optimal component positioning is crucial when ceramic-on-ceramic components are used. These components should be placed at less than 45° abduction and 10-15° anteversion on the acetabular side to optimize the distribution of forces over the surfaces of the femoral head and cup^{1,9,11,16)}. In our case, abduction and anteversion angles were 46.14° and 36.09°, respectively (Fig. 4). The presumptive cause of the refracture was positioning of the cup in excessive anteversion, which caused impingement between the posterior aspect of the stem neck and the liner followed by subluxation of the head, and head to liner impact due to reduction.

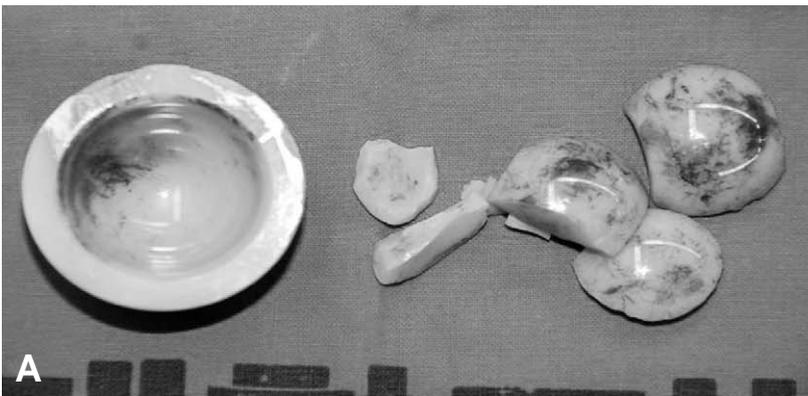
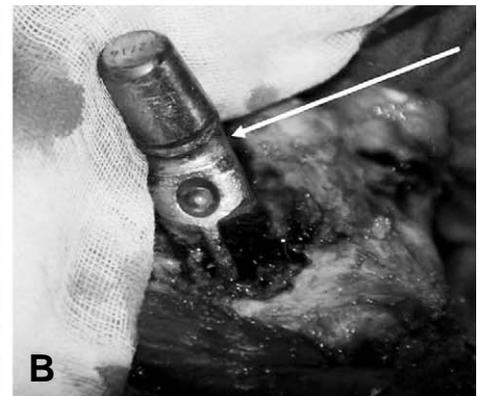
The patient underwent a second revision surgery. Multifragmentary fractured particles of the ceramic head (one on the apical segment and four on the lateral segment) and dark metallic stains were observed on the medial surface of the fractured head. This stain was revealed Ti particles on EDAX study. At the peripheral rim of the ceramic liner, a similar metallic stain and chip fractures were found (Fig. 5A). Interestingly, a groove was observed around the lateral and posterior neck base of the femoral stem (Fig. 5B), indicating impingement between the stem neck and the ceramic liner. During second revision surgery, the fractured ceramic head and the ceramic liner were replaced with 28 mm CoCr medium neck and an elevated-polyethylene liner, which were both replaced anterosuperiorly instead of posteriorly, to overcome excessive anteversion (Fig. 6). The trunion of the femoral stem was retained, although a portion of it was scratched and grooved, because the femoral stem showed bony ingrowth stabilization. Two years after second revision, no postoperative complication or dislocation had occurred, and he was working

Fig. 5. (A) A rim fracture and metal staining of the ceramic liner and multiple fragments of the ceramic head and (B) a deep groove (white arrow) was observed on the lateral base of the femoral stem.

Retrieved ceramic femoral heads have shown that metal staining, which appears as dark marks on the inner inferior surfaces of ceramic liners²²⁻²⁴⁾, is caused by metal transfer to the ceramic surface when a head contacts a metal shell during, for example, femoral head reduction or femoral head dislocation¹¹⁾. In our case, metallic staining was observed on the articular surfaces and lips of the ceramic liner, and multiple scratches were the observed on the taper of neck of the retained femoral stem (Fig. 5). Furthermore, EDAX showed that the metal staining on the liner rim was caused by Ti-alloy.

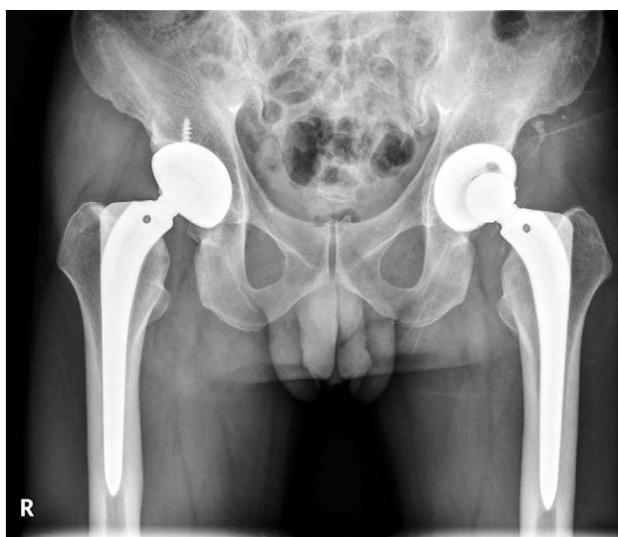
Fig. 6. New polyethylene liner and metal head were fitted to retained metal shell and the existing femoral component and small pieces of particles can be seen at posterosuperior capsule.

Several options are available for correcting a malpositioned metal shell and a femoral stem with a damaged taper by new implantation of the metal shell and femoral stem with large head or isolated revision on metal shell. We decided to retain all metal components because stable bony ingrowth of the metal shell and femoral component were evident, and thus, we replaced the articular portion only. We choose an elevated polyethylene liner and metal head combination to overcome the damaged taper and to compensate for anteversion of the metal cup. In the present case, during revision, to reduce excessive anteversion, the elevated rim of the polyethylene liner was replaced anterosuperiorly to compensate excessive anteversion and to use 28 mm CoCr metal head on the damaged trunion. After two
