## **Radiologic Findings in Cases Involving Complications Arising from Total Knee Arthroplasty<sup>1</sup>**

Deok Ho Nam, M.D., Kyung Nam Ryu, M.D., Dae Kyung Bae, M.D.<sup>2</sup>

<sup>1</sup>*Department of Diagnostic Radiology, Kyung Hee University Hospital*

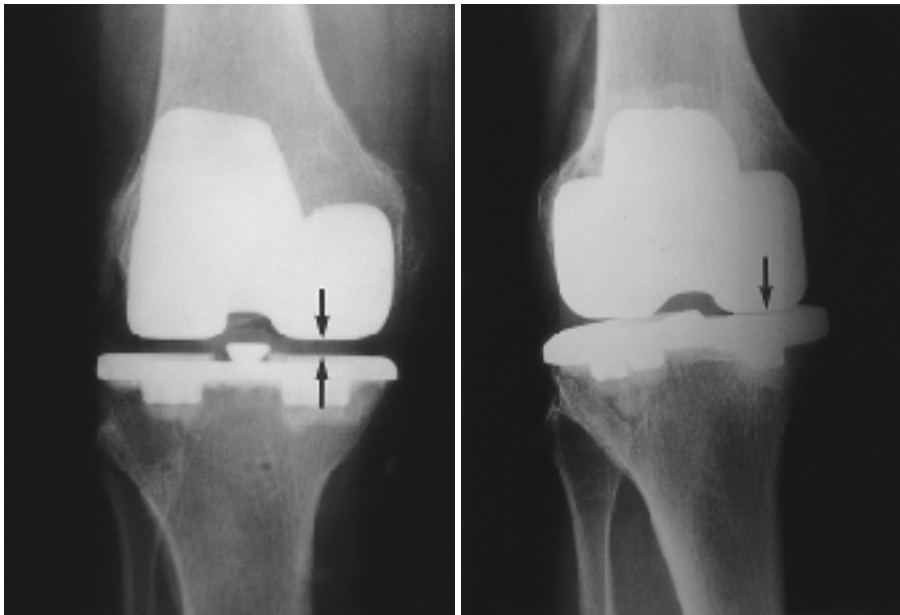
Fig. 1. A 64-year-old woman with prosthesis wearing at 7 years after TKA. A. Initially, the thickness of radiolucent zone polyethylene is 3.5mm at medial(arrows) and lateral tibial plateau. The femorotibial alignment is good. B. The polyethylene shows severe wearing at medial side(arrow) and the knee joint shows varus deformity at 7 years after TKA.

(Fig. 1A,B).

90% (abrasion), (burnish-  
ing), (deformation), 50%  
가 (delamination) 37% 가

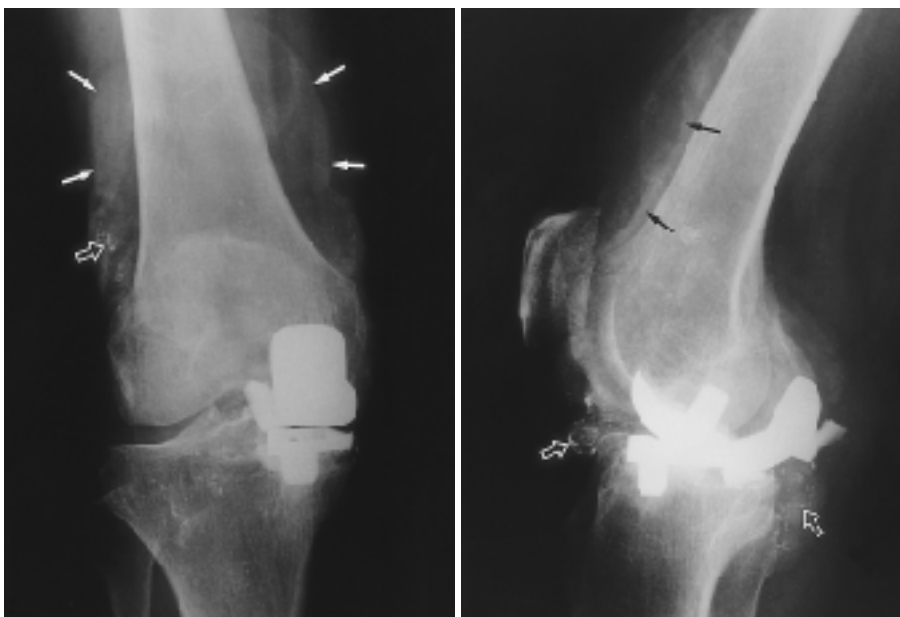
Fig. 2. A 73-year-old woman with metallosis at 4 years after TKA. A, B. The radiographs show diffuse cloud like increased opacities(arrows) with multiple tiny metal densities(open arrows) around knee joint(metal-line sign), which represent synovitis by wearing materials from prosthesis. The unilateral prosthesis shows wearing.

metal line sign

(Fig. 2A,B).

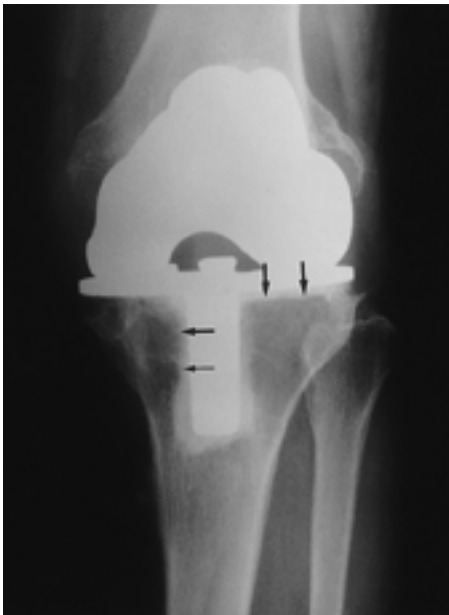
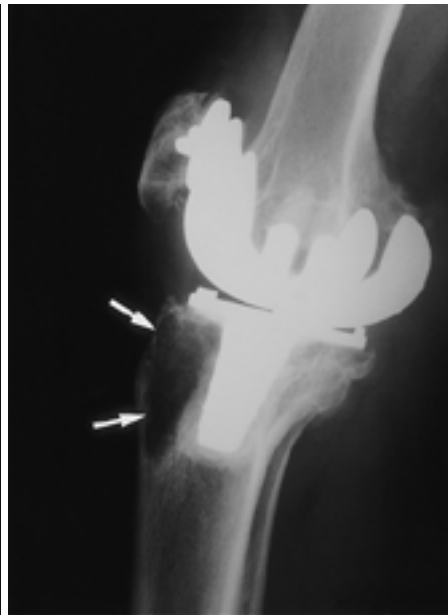
Fig. 3. A 66-year-old woman with osteolysis at 8 years after TKA.  
 A, B. Diffuse osteolytic areas(arrows) are seen at medial and lateral tibial condyles around the stem of prosthesis. The polyethylene of prosthesis shows severe wearing.

(Fig. 3A,B), , 4) 가 - , (4). 12% , 1 (5), (malalignment), 가 가 , (Fig. 4A,B). (1). 1) 2 , 가 , 2) , 3) .

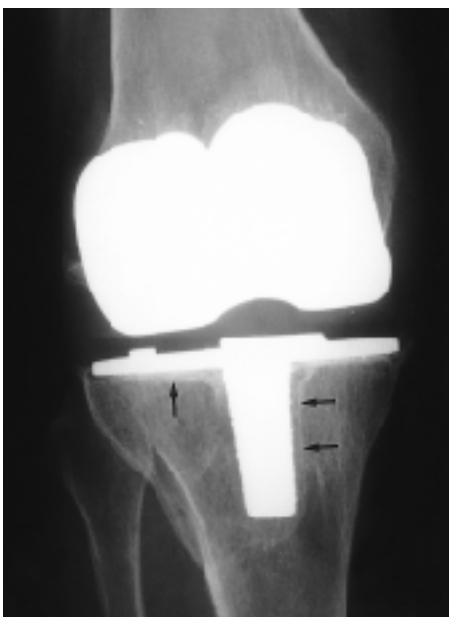
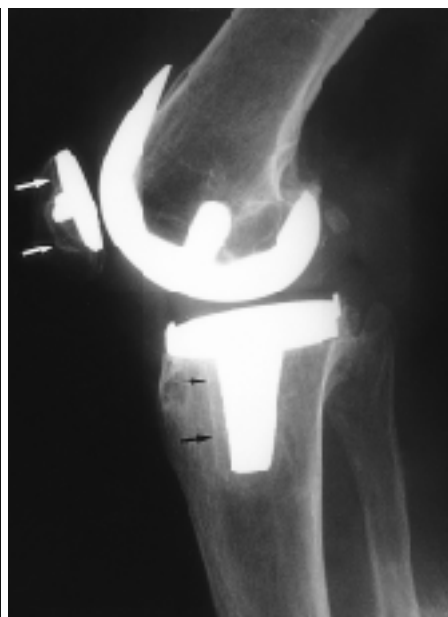
Fig. 4. A 66-year-old woman with loosening at 7 years after TKA.  
 The radiolucent zones with thin and sharp sclerotic margin(arrows) are seen at tibial(A,B) and patellar prosthesis(B). The thickness of radiolucent zone is about 2.5mm.

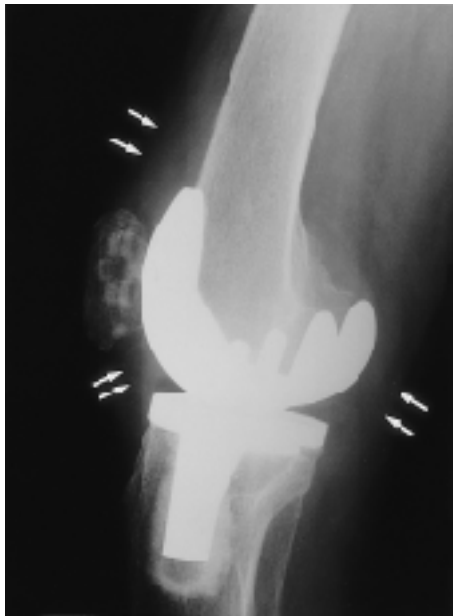
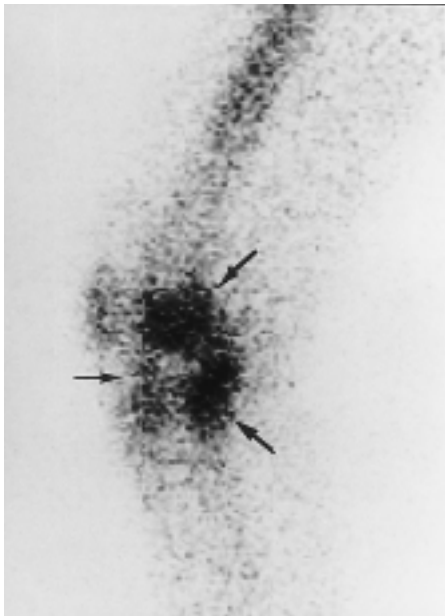
Fig. 5. A 66-year-old woman with infection at 5 months after TKA.

A. Soft tissue swelling(arrows) is seen around the knee joint. But the irregular radiolucent zone or loosening is minimal.

B. Gallium scan. There is increased uptake about the both femoral and tibial components(arrows) of the TKA after 72 hours.

가 (radiodense line) , ESR, (radiodense line) , (5). 가 (Fig. 5B). 가 (Fig. 5A). , 2) - 1) 가 , 3) , 4) techneitium-99m phosphate complex 가가 6-12

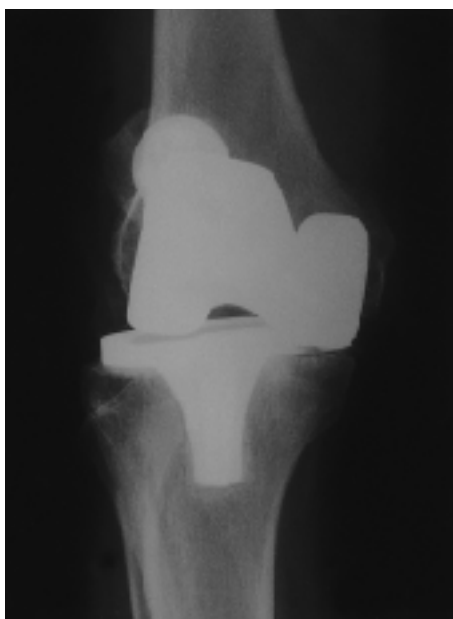
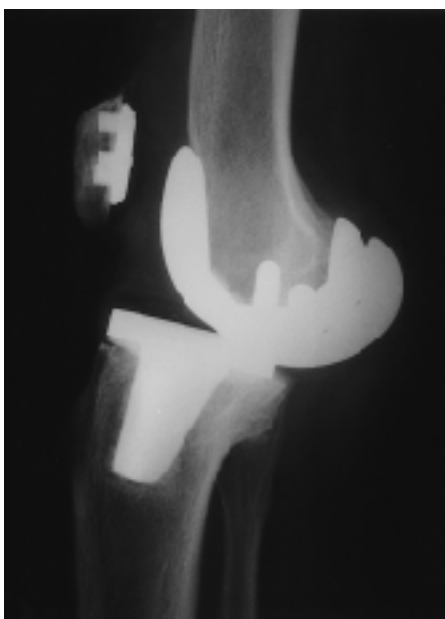
Fig. 6. A 62-year-old woman with femorotibial subluxation at 3 years after TKA.

A, B. The tibia shows anterior subluxation with loosening of tibial prosthesis.

가 가 (Fig. 6A,B)(4). , 2 (4). 3% , (6). 가 , 3 가 , 1-1.5 , 7 가 (7). (stem) (Fig. 7A, 가 tracking, B)(1).

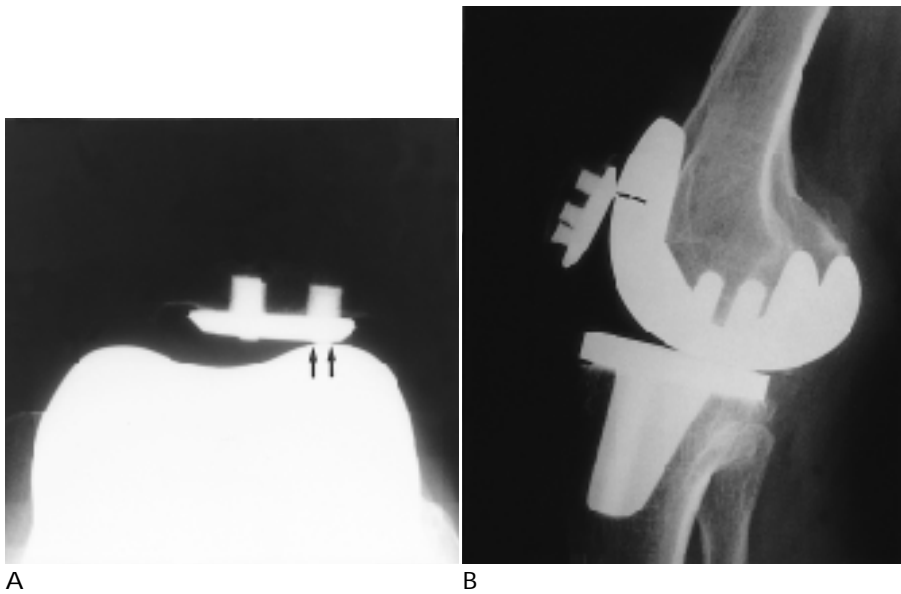
Fig. 9. A 65-year-old woman with patellar component subluxation and wearing at 8 years after TKA. A, B. The patellar prosthesis is subluxated to lateral side. And the absence of the normal radiolucent polyethylene between the patella and the femoral component shows metal-on-metal contact(arrows).

가 (7). 가 (7). Q angle 가 , tracking (retinaculum)가 가 (Fig. 8A,B) (10). 가 가 가 가 (Fig. 9A,B) (5,8). 가 peg-metal back , metal back peg-metal backing 가 metal plate 가 . (10).

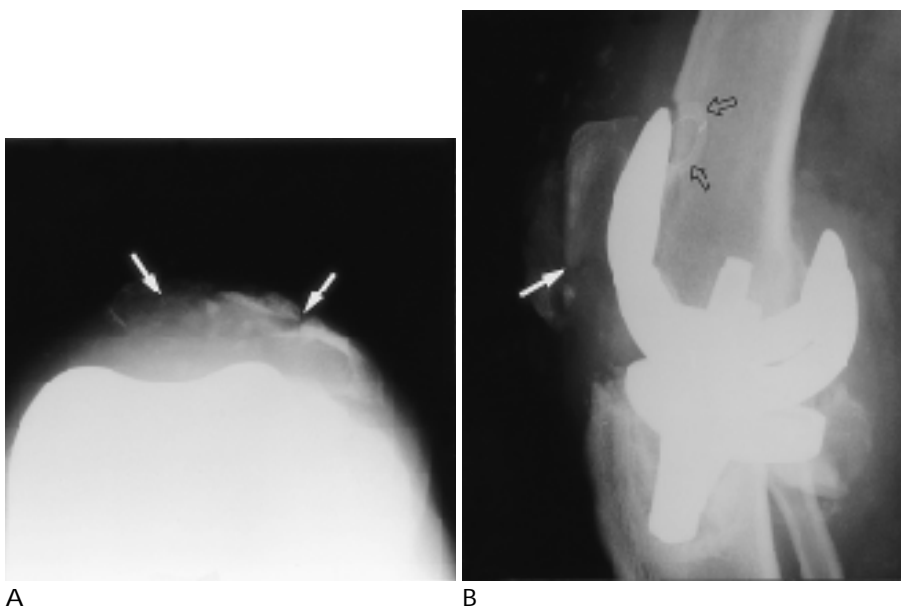
Fig. 10. A 55-year-old man with patellar fracture at 2 years after TKA. A. The skyline radiograph shows patellar fracture and fragmentation(arrows). B. The lateral radiograph shows patellar fracture(arrows) accompanied by patellar component displacement(open arrows).

5% , (patellar tendon) (avulsion) , (8, 9). (Fig. 10A,B). 가 , an- choring hole (lateral release , lateral superior geniculated artery가 , (infrap- atellar fat pad) , 가 가 가 . 가 가 가 (7).
