J Korean Radiol Soc 2003;48:159 - 162

## Pulmonary Embolism Caused by Acrylic Cement: Report of Two Cases Developed as a Complication of Percutaneous Vertebroplasty<sup>1</sup>

Percutaneous vertebroplasty is an effective, minimally invasive procedure for the treatment of vertebral compression fractures, and is a technique for treating lower back pain that appears to be increasingly popular throughout the world. We experienced two cases involving a rare complication of percutaneous vertebroplasty, namely pulmonary embolism caused by acrylic cement. One patient showed no subjective symptoms after vertebroplasty, while the other experienced chest pain. In the former, fluoroscopy demonstrated perivertebral venous leakage during vertebroplasty, and at chest radiography, tubular or branching high-density linear structures were observed. In addition, intravascular emboli were identified at CT. In the second patient, symptomatic therapy led to reduced chest pain.

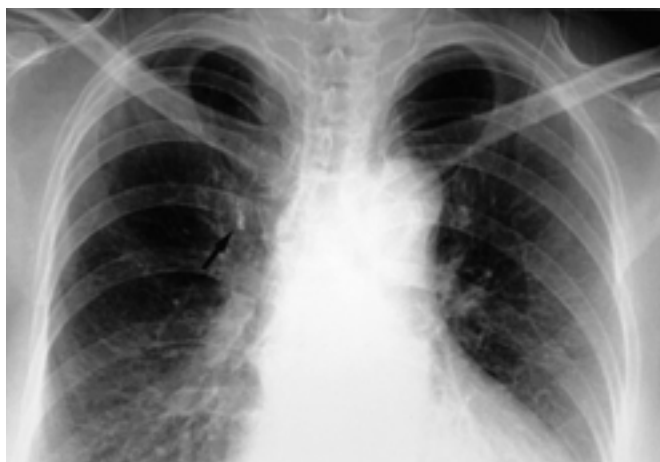
**Fig. 1.** A 68-year-old woman with benign compression fracture. The vascular leak in this patient was identified during the procedure, and further injection was terminated immediately.

**A.** Chest radiograph shows thread-like increased opacity (arrow) in the right upper lung zone.

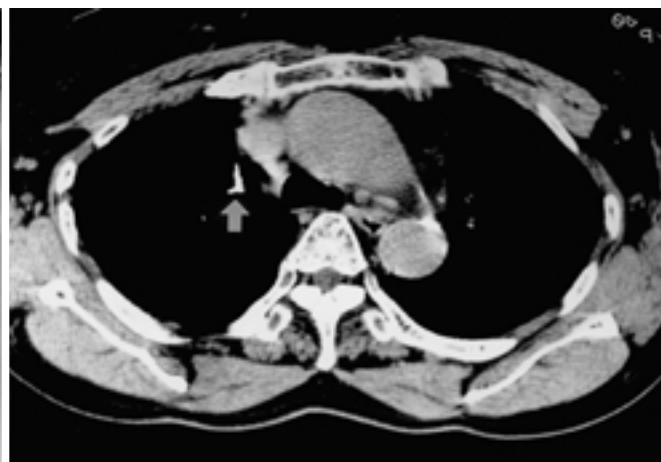
B

**B.** CT scan obtained at the level of the carina shows high-density intraluminal branching material (white arrow) within the pulmonary artery in the right upper lobe.

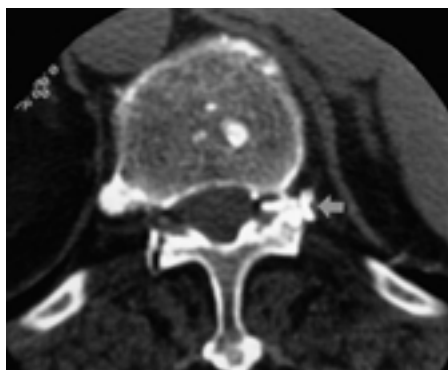
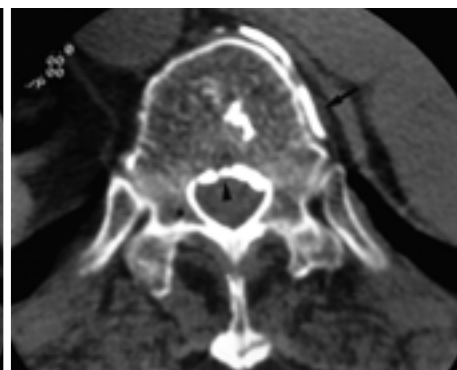
C

**C, D.** CT scan obtained through the level of T12 shows cement within the intervertebral veins (white arrow). Note emboli of cement in left latero-vertebral vein draining in the vena cava (black arrow) and the epidural space leak (arrowhead) is also seen.

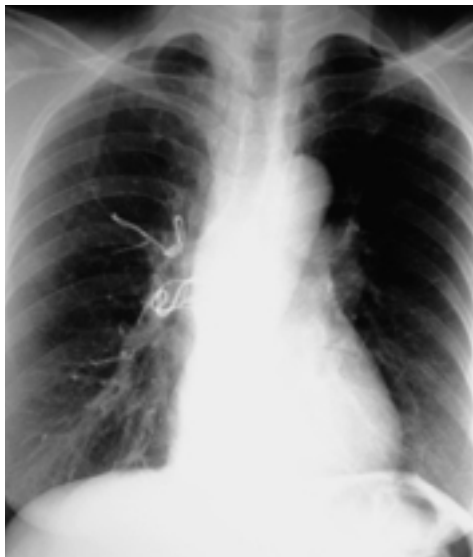
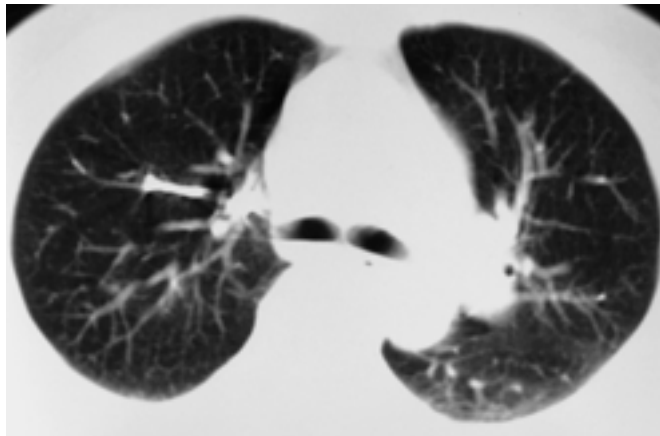
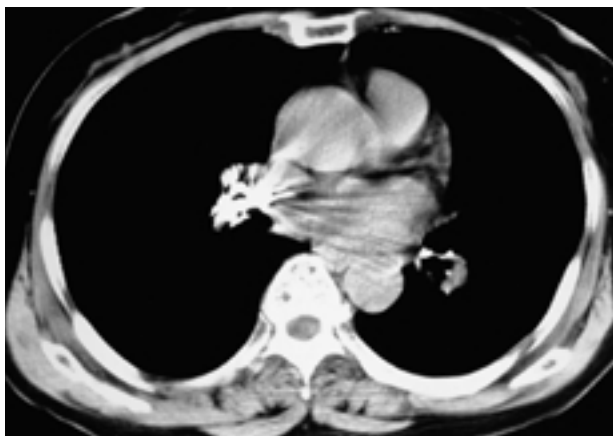
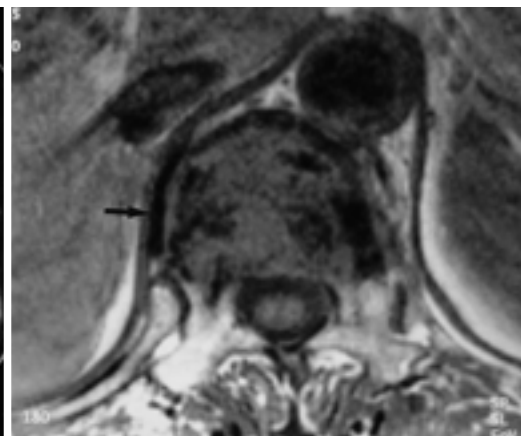
**Fig. 2.** A 67-year-old woman with benign compression fracture was treated by percutaneous vertebroplasty 3 weeks ago.  
**A.** Chest radiograph shows multiple high-density thread-like opacities outlining pulmonary vessels.  
**B.** CT scan obtained with lung windows shows intra-luminal emboli of cement in upper-lobe segmental vessels in the right lung.  
**C.** Non-enhanced chest CT scan at the level of bronchus intermedius demonstrates high-density intra-luminal cement in the right interlobar artery and in the left lower lobar artery.  
**D.** T1-weighted axial image obtained at the level of the T12 shows linear low signal (arrow), suggesting emboli of cement in the paravertebral veins.

(Fig. 2A). CT  
(Fig. 2B, C).

(Fig. 2D).
