# A Failure of the Locking System of the Acetabular Assembly in a Total Hip Replacement

*In this study, the author presents the case of one patient who had a Harris-Galante total hip replacement for pigmented villonodular synovitis of the left hip joint, the locking system failed and separation of the polyethylene liner from the acetabular metal shell occurred while the closed reduction of the posterior dislocation of the femoral prosthesis was performed. This study indicates that the design of the acetabular assembly should be modified. The gap between the rims of metal shell and polyethylene liner should be reduced or eliminated.*

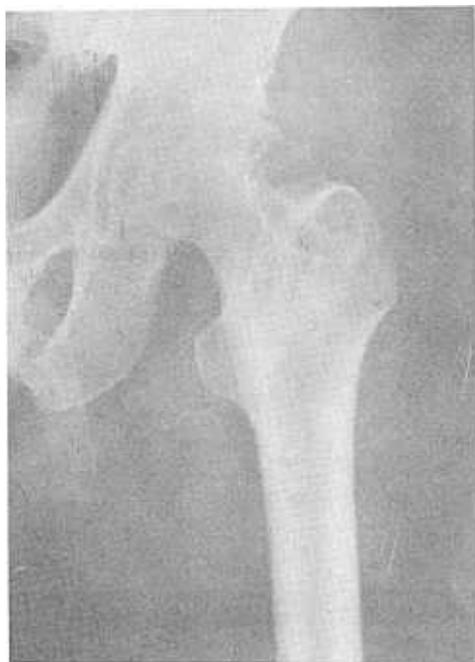
**Fig. 1.** Radiograph of the left hip joint reveals complete loss of cartilaginous space of the hip joint, multiple cysts in the acetabulum and femoral head and excavating destructive lesion in the lateral aspect of the femoral neck.

On September 8, 1986, a sixty-four-year-old man was seen for the left hip joint pain for three years' duration with no history of antecedent trauma or disease. Roentgenograms showed a complete loss of cartilaginous space of the hip joint, multiple cysts in the acetabulum and femoral head and excavating destructive lesion in the lateral aspect of the left femoral neck (Fig. 1). These findings led me to suspect pigmented villonodular synovitis, which was subsequently confirmed by a histopathological analysis. Through a postero-lateral approach, a Harris-Galante cementless total hip prosthesis was implanted in the left hip joint, using a 13mm diameter femoral stem with a medium sized femoral neck, 32mm femoral head, and an acetabular metal shell of 54mm in the outer diameter. A polyethylene liner of 32mm inner diameter was assembled. Postoperative radiograph showed the prosthesis in place (Fig. 2). The patient's recovery was uneventful. He was discharged from the hospital 8 days after the operation. At that time he was walking with bilateral crutches pain-free. Two weeks after the operation, while getting out a bed, he attempted to stand on the sound(right) limb while the left one remained on the bed. Apparently the hip was markedly flexed and then adducted as he attempted to slide the left limb from the bed to the floor. The patient felt a sudden, severe pain in the left hip and thereafter could not walk. He was immediately brought to the emergency room by an ambulance.

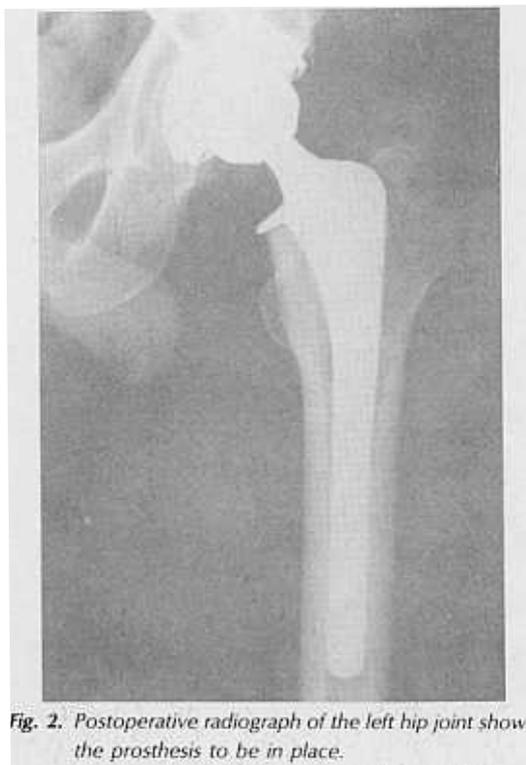
**Fig. 2.** Postoperative radiograph of the left hip joint shows the prosthesis to be in place.

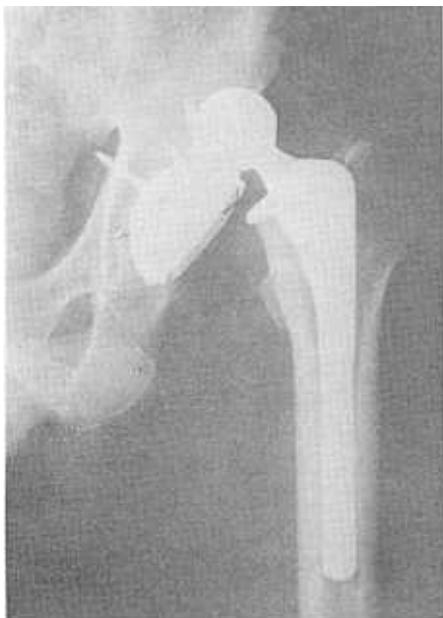
**Fig. 3.** Pre-reduction radiograph shows that the prosthetic femoral head is dislocated posteriorly while the acetabular component is embedded in the acetabulum.

tr emity was held in a slight flexion and adduction and also slightly rotated internally. The patient had a painful restriction of movement of the joint. Radiographs showed that the prosthetic femoral head was dislocated posteriorly while the acetabular component was embedded in the acetabulum (Fig. 3). Although closed reduction was achieved in the emergency room, a severe crepitus was audible when the hip joint was ranged. Post-reduction radiographs revealed failure in the attempt at a concentric reduction (Fig. 4). It was suspected that the interposing loose body between the femoral and acetabular components might have prevented the concentric reduction of the hip joint.

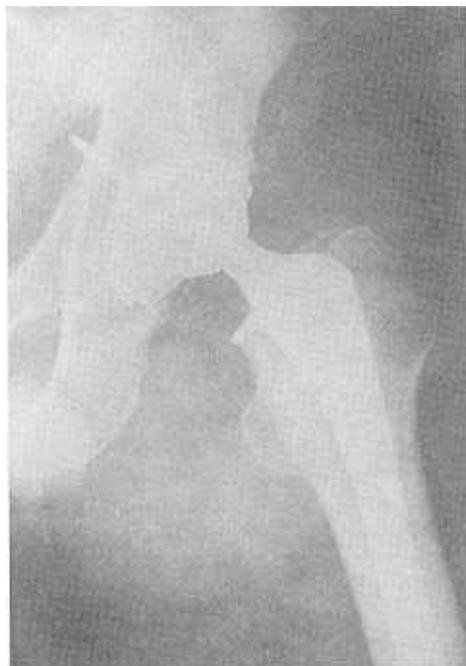
**Fig. 4.** Post-reduction radiograph reveals failure to achieve a concentric reduction of the left hip joint.

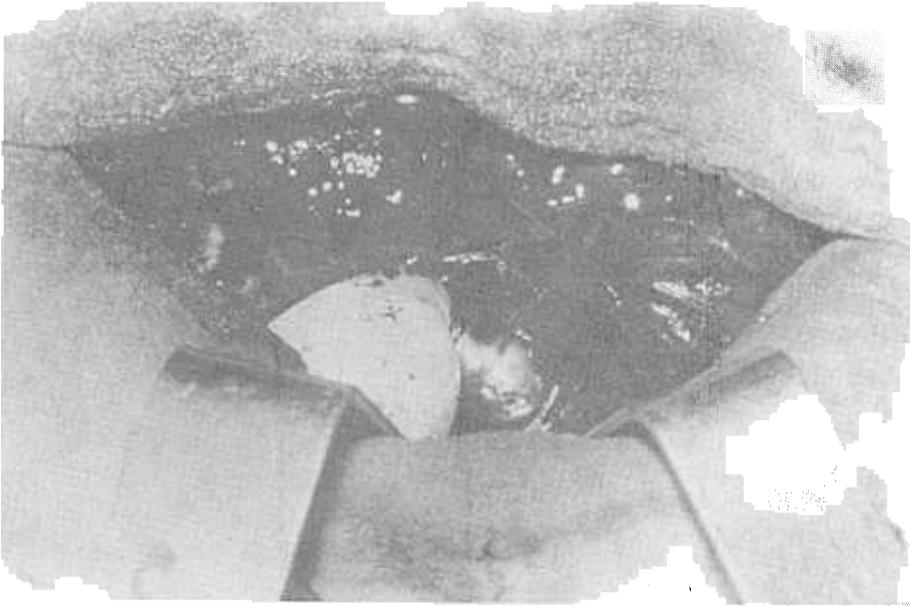
**Fig. 5.** The operative photograph demonstrates that the polyethylene liner has been completely separated from the acetabular metal shell and is found inferior to the acetabulum while the femoral head is contained in the acetabular metal shell.

On September 26, 1986, the patient was brought to the operating room for his hip to be explored. The operative findings demonstrated that the polyethylene liner had been completely separated from the acetabular metal shell and was found inferior to the acetabulum while the femoral head was contained in the acetabular metal shell (Fig. 5). The separated polyethylene liner was found deformed. The femoral head and the acetabular metal shell were intact.

The Harris-Galante acetabular assembly has a gap between the rims of the metal shell and the polyethylene liner, which is approximately 5 millimeters. It appears that the failure of the locking mechanism in this patient probably has been the result of the impingement of the polyethylene liner by the inferior-medial portion of the femoral head. What seems to have been the case is that while traction was applied on the left lower extremity, the dislocated femoral head was compressed over the acetabular rim by hip muscles and an inferior-medial portion of the femoral head was caught in the gap between the rims of the metal shell and the polyethylene liner. And then a further traction seems to have caused an impingement by the femoral head on the rim of the polyethylene liner and in result the separation of the polyethylene liner occurred. In this case, a simple closed reduction of the dislocated femoral head could have been possible without requiring the second operation, had the femoral head not been caught in the gap between the liner and metal shell, resulting in the separation of the assembly.

A new polyethylene liner was assembled on the metal shell and the femoral component was reduced into the acetabular component. The patient was then placed in Thomas splint for 2 days and thereafter he was gradually allowed to walk, first with a walker

Consequently, I believe that the design of the acetabular assembly should be modified and the gap between the rims of the metal shell and the polyethylene liner should be either reduced to minimal or possibly eliminated all together.

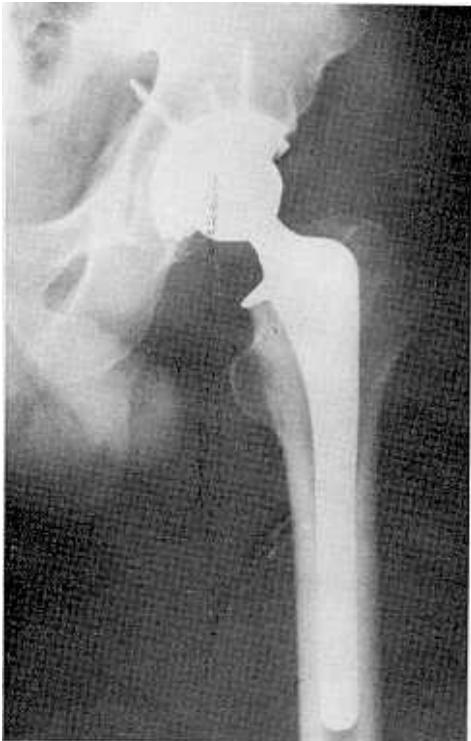
**Fig. 6.** Post-revision radiograph shows that prosthesis is intact and in place.

and then with bilateral crutches. When he was last seen, four weeks postoperatively, the hip was stable and painless and he was walking with bilateral crutches. Radiographs showed that prosthesis was intact and in place (Fig. 6).
