Antibiotic-impregnated Cement Plate for the Treatment of Infected Periprosthetic Femoral Fracture after Cementless Total Hip Arthroplasty - A Case Report -

Key Words: Antibiotic-impregnated cement plate, Infected periprosthetic fracture, Total hip arthroplasty

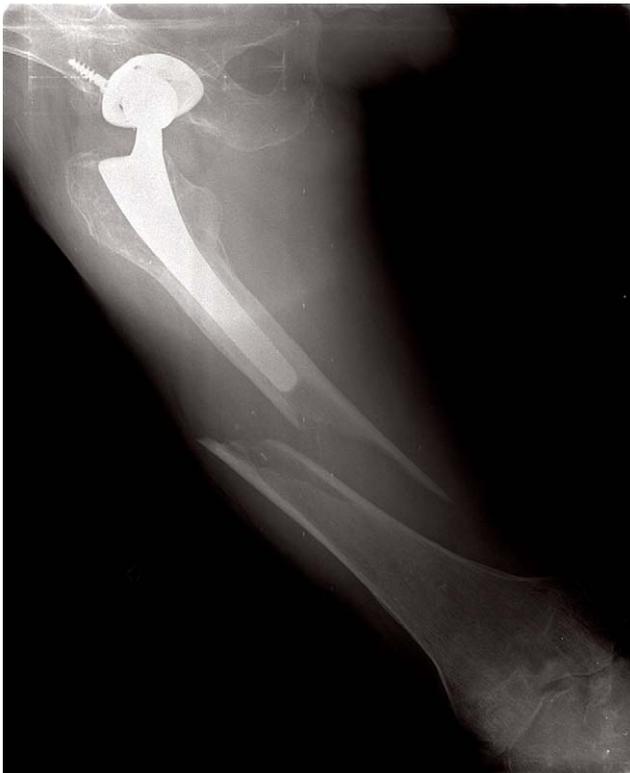
Fig. 1. Anteroposterior hip radiograph showing the Vancouver type C periprosthetic fracture without component loosening.

A 62-year-old man with essential hypertension and chronic obstructive pulmonary disease had bilateral avascular necrosis of the femoral head and underwent bilateral cementless THA 18 years prior to presentation. In December 2009, he slipped and fell and subsequently developed painful swelling of the right thigh. The initial diagnosis was a right periprosthetic femoral fracture. On plain radiographs, his right femur showed an oblique fracture distal to the stem tip, which was classified as type C according to the Vancouver classification, without loosening around femoral stem (Fig. 1).

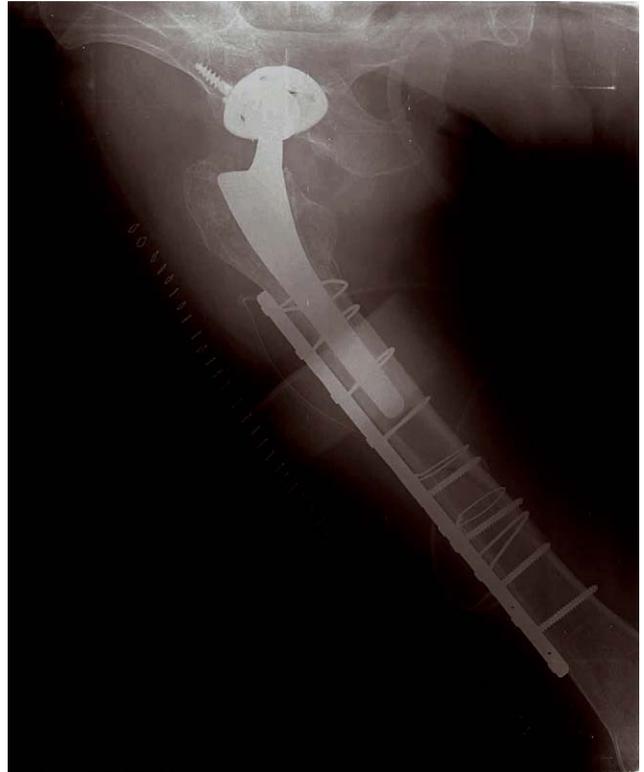
Fig. 2. Anteroposterior hip radiograph showing open reduction and internal fixation using a cable plate.

He underwent open reduction and internal fixation for the right periprosthetic fracture using a cable plate (Fig. 2). Two months after surgery, he experienced painful swelling and a sensation of heat in his right thigh. Minimal wire loosening was seen on plain radiographs, and we choose observation because callus formation was observed at the fracture site. After one month, the wire loosening progressed and a varus deformity occurred following the collapse of the medial wall of femoral shaft (Fig. 3). C-reactive protein was elevated from 1.73 to 5.12 mg/dL,

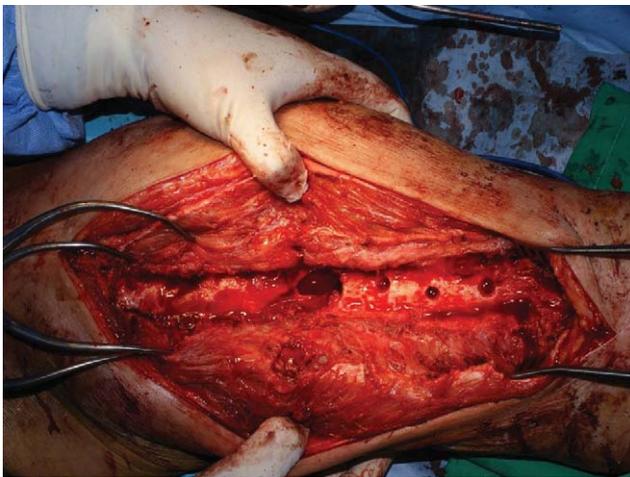
Fig. 4. Intraoperative photograph showing the bony defect on the lateral wall of the femoral shaft.

and the erythrocyte sedimentation rate was continuously as high as 120 mm/hr during the three months after surgery. We suspected the presence of deep infection around the femoral fracture site. The cable plate was removed, and surgical irrigation and debridement of the fracture site were performed without exposure of the hip implants. Intraoperative examination of frozen-section specimens showed acute inflammation. Because there was a bony defect on the lateral wall of the femoral shaft (3×5 cm) after debridement, proper filling of the defect was needed for fixation (Fig. 4). The medial callus and soft tissue were not dissected in order to provide a hinge for plate fixation, similar to three-point fixation. The entire surgical field was covered with a vinyl sheet for contouring of the defect. The antibiotic-impregnated cement (2 g vancomycin and 1 g cefamandole per 3 packs

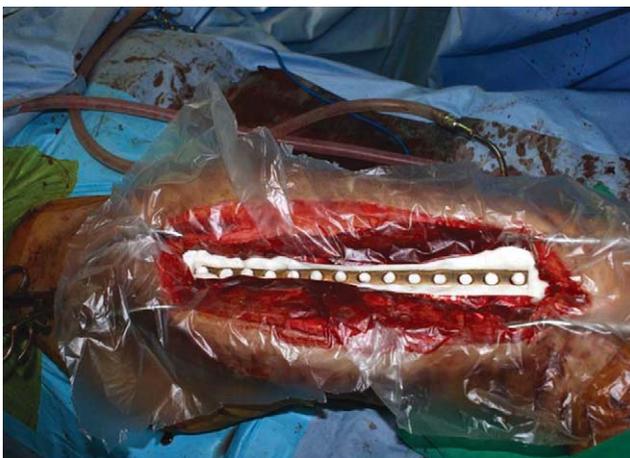
Fig. 5. Intraoperative photograph showing antibiotic-impregnated cement and plate over a vinyl cover.

of cement) was prepared and poured onto to the vinyl sheet before the cement became firm. The plate was mounted and pressure was applied to cause it to sink down under the cement. After curing of the cement, the cement-plate complex was separated from the vinyl sheet (Fig. 5). The antibiotic-impregnated cement-plate complex was placed over the defect site and appropriate stability was achieved with wiring and a medial soft tissue hinge.

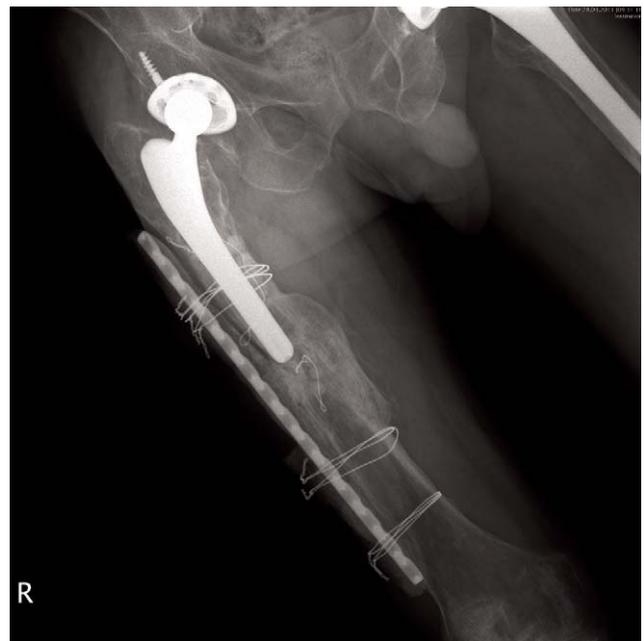
Fig. 6. Anteroposterior hip radiograph at 12 months after the operation showing bone union.

C-reactive protein decreased from 1.59 mg/dL 2 weeks after surgery to 0.5 mg/dL 3 months after surgery. The erythrocyte sedimentation rate also decreased from 84 to 77 mm/hr during the same period. Twelve months after surgery, radiologic bone union was seen on follow-up x-rays (Fig. 6). The patient was able to walk without any support and was pain free.
