What Happened to Him Using the Freight Elevator: Fall from Height or Caught Between?

*Forensic Medicine Division,
National Forensic Service, Seoul,
Korea*

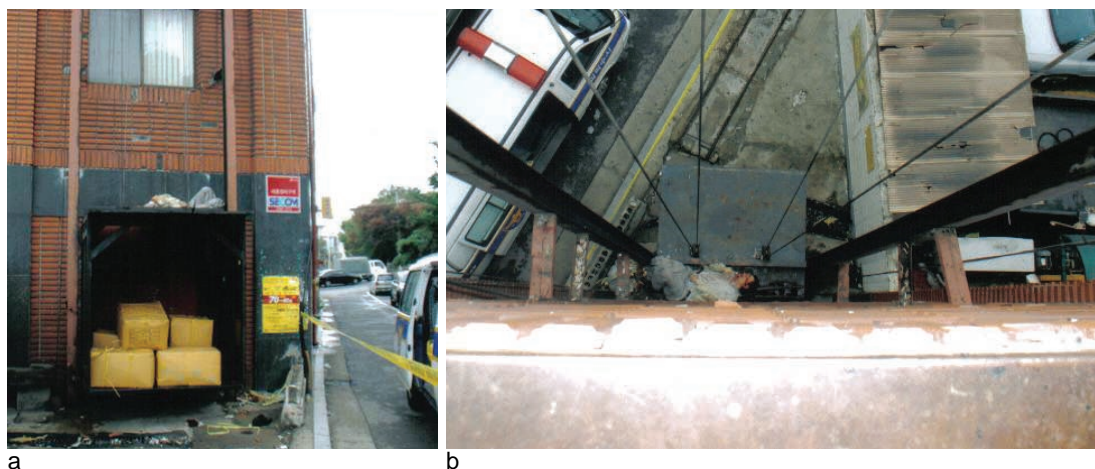
Fig. 1. The freight elevator system is facilitated on the outside of the factory building. The elevator car is seen on the ground floor. The deceased is seen on the roof of the elevator car and several boxes of the goods are loaded inside of the elevator car which has no door with just iron bar frames structured in a cubic form (a). It is seen from the third floor window outside. The dead body is placed on the roof of the elevator car, near the building wall (b).

A 53-year-old man was found dead on the roof of a freight elevator car installed on an outer surface of a four-story building in the autumn. The decedent was a thread reseller. The factory in the building asked him to take back several boxes of defective thread he had supplied. And he went to the building to get back those on the previous evening. At the death scene, the elevator car was on the ground level. The elevator system lacked doors and structures to separate the freight car from the building wall. Five boxes of defective thread were inside on the floor of the elevator car. He was lying on the roof of the elevator car near the building wall (Fig. 1). Police assumed the

The death could have been prevented with proper safety measurement done before the accident. The elevator of this case violated Korean government regulations regarding elevators in several aspects (i.e. not installing doors). In addition to the proper installment of elevators, timely and continued maintenance must be made because older elevators have higher accident rate.²⁾ This case was required considerable amount of time and effort in careful

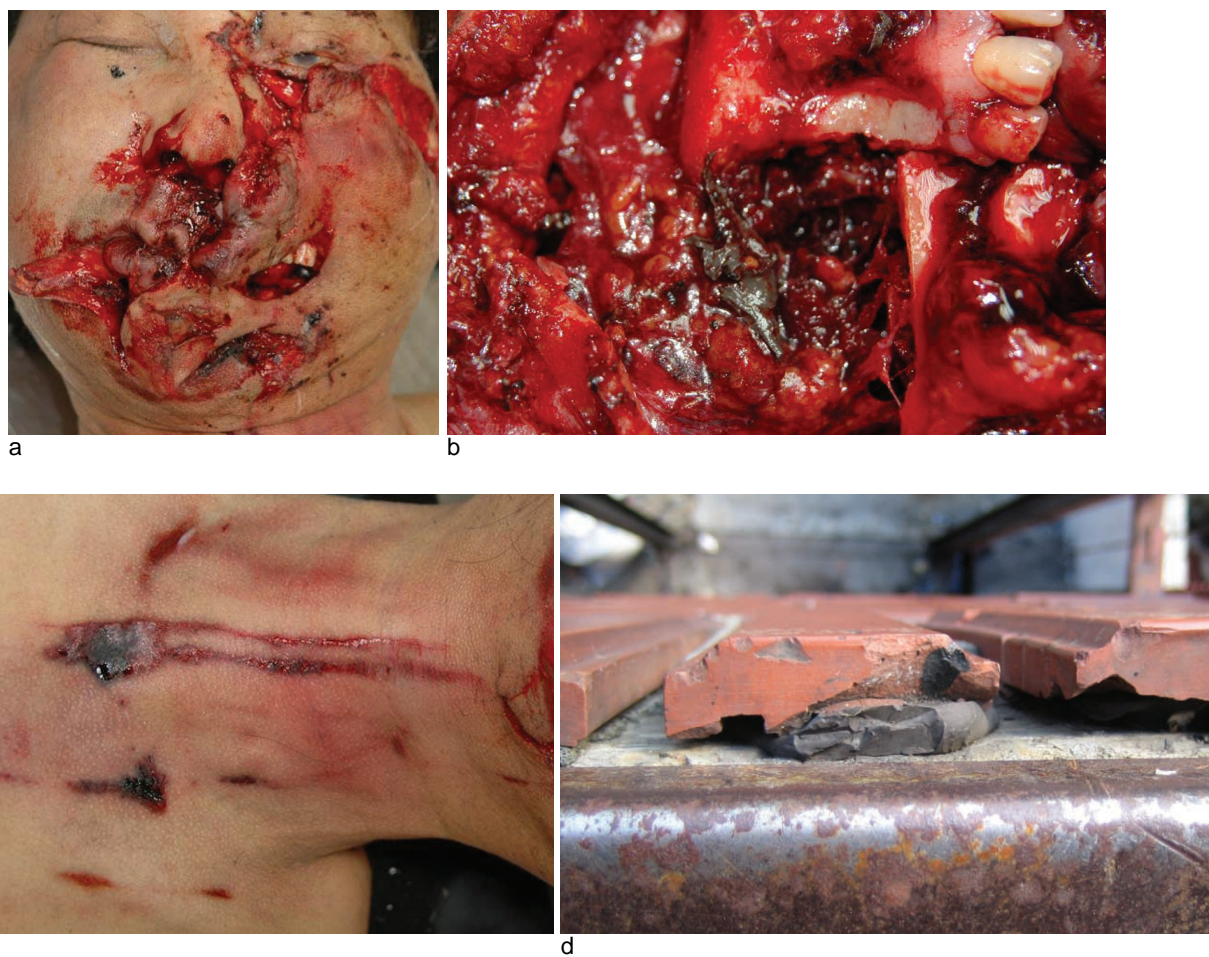
Fig. 2. Flayed and crushed pattern of lacerations are developed on the orofacial area (a). A black silicon rubber fragment is seen in the mandibular fracture site (b). Linear abrasions from the chin to the clavicular area are formed parallel to the neck (c). And theses parallel marks are thought to match up with bricks on the building wall, also there are black silicon rubber materials (d).

The deceased showed multiple curvilinear facial lacerations. They were located between the left ear lobe and right side of the chin. Left lower quadrant of facial skin was flayed (Fig. 2a). Disruption of masseter muscles and crushed fracture of mental protuberance were noted. A fragment of black rubbery material was found within the crushed surface (Fig. 2b). Two narrow parallel lines of abrasion (width: 0.5 cm and 1.0 cm) connecting the chin and the medial end of the right clavicle were noted accompanying smaller linear abrasions scattered parallel (Fig. 2c). And we thought these parallel marks matched up with bricks on the building wall (Fig. 2d). Additionally several fragments of dried soft tissue were found on the lower horizontal frame of the third floor window. Two horizontal lines of contusion (distance: 6.5 cm) were present at the back of neck (Fig. 3a). And we thought theses horizontal lines matched up with width between a frame bar of the roof of the elevator car and the building wall (Fig. 3b). Several bracket shaped abrasions were on left shoulder and both thighs. Posterolateral aspect of the left thigh showed three linear abrasions coursing the whole length of the thigh. Each of ankles and dorsal surfaces of feet showed a linear laceration.

Toxicology analysis was negative. Infrared spectroscopy analysis showed materialistic characteristics were identical between the black rubbery material from the mandible fracture site and silicone adhesive from the outer surface of the building.

Along with these contradictory findings, the silicone fragment found from face and the adipose tissue on the building wall lead to the conclusion that he was caught between the elevator car frame and the building wall. The posterior neck of the decedent might have been impinged between a frame bar of the roof of the elevator car and the building wall somehow when the elevator was descending. The body might have dragged down along the wall making the linear abrasions and lacerations all over the body lengthwise. The shearing force could have caused the facial and spinal injuries with traction pattern. As the elevator came down, the gap between the elevator roof and the building wall must have been widened enough to allow the head pass through at windows. After the head and neck was freed from the gap, the body might have been moved toward on the roof of the elevator car as found on the death scene by gravitational force.

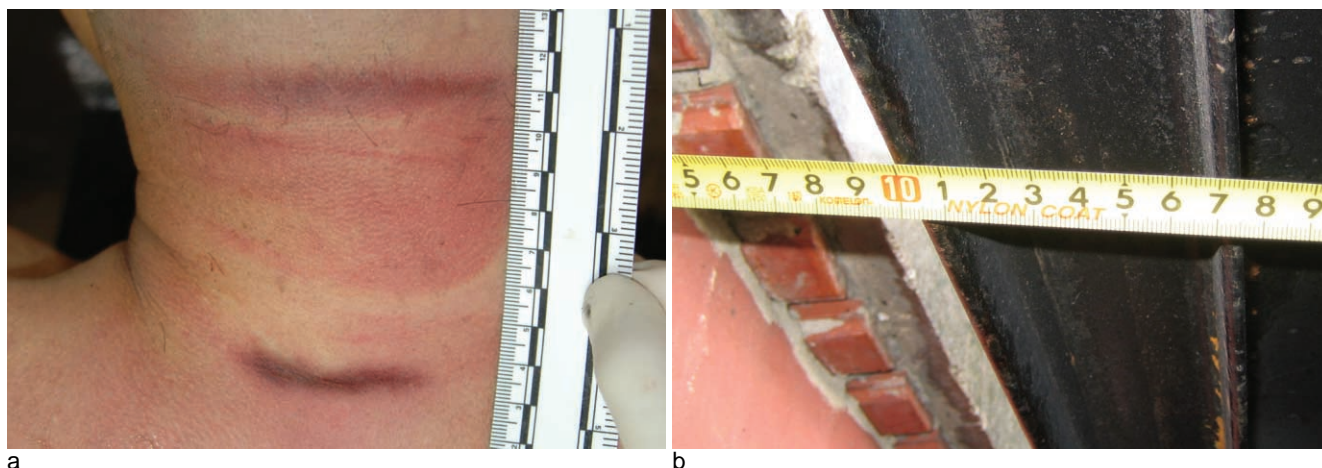
Fig. 3. The parallel linear contusions on the posterior neck (a) are a form of patterned injury, being compatible with the iron frame bars of the roof of the elevator car (b).
