# Fracture resistances of zirconia, cast Ni-Cr, and fiber-glass composite posts under all-ceramic crowns in endodontically treated premolars

**KEYWORDS:** Fracture; Endodontically treated teeth; Post and core; Zirconia

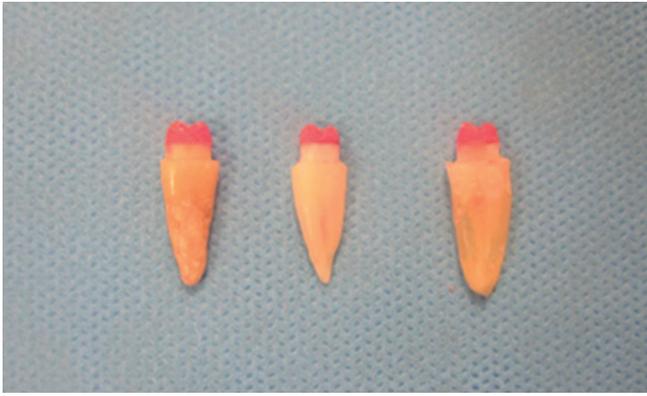
**Fig. 1.** Prepared acrylic patterns of post-cores in the first two groups.

In order to prepare the teeth to receive all-ceramic crowns, a 1-mm wide radial shoulder finishing line was prepared at 0.5 mm above the CEJ. Leaving 4 mm of gutta percha for the apical seal, the dowel space was prepared with the use of an appropriate size of peeso reamer (Mani, Utsunomiya, Japan). For the teeth in the first two groups, one-piece patterns of post and cores were made directly with self-cure acrylic resin (GC Corporation, Tokyo, Japan) (Fig. 1).

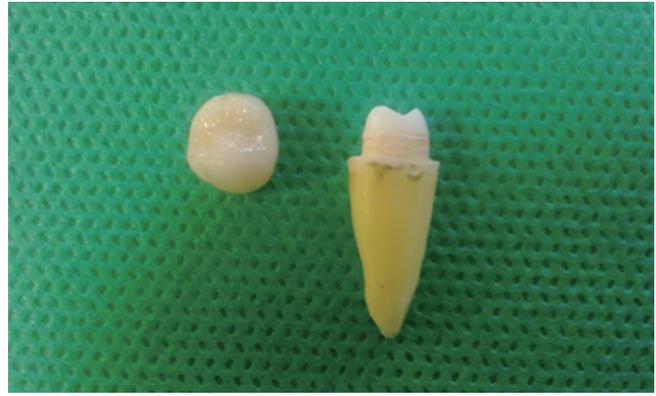
**Fig. 2.** A sample and an all ceramic crown with zirconia coping.

The appropriate size of fiber-glass post was selected, as confirmed by radiography, and cemented as described above (Panavia F2.0, Kuraray, Noritake, Dental Inc., Tokyo, Japan). The composite core was then formed. All samples were next scanned to receive all-ceramic crowns with zirconia coping using the CAD-CAM technique (Cerec 4.0, Sirona Dental Systems, Bensheim, Germany). Prepared crowns were cemented with Panavia cement, using the same protocol described above (Fig. 2).

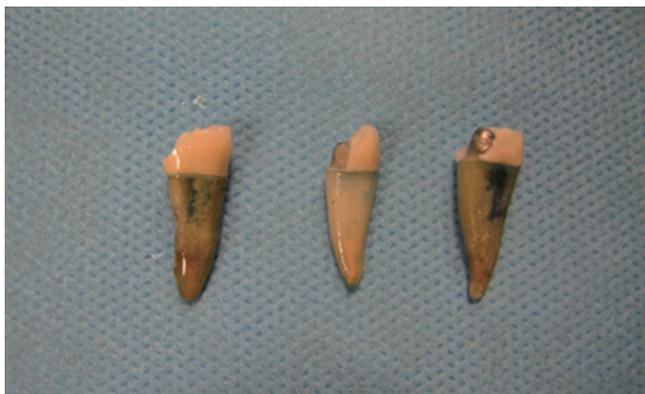
**Fig. 5.** Porcelain fracture in cast Ni-Cr post-core system.

In the cast metal group, the majority of fractures occurred in the veneering porcelain, with one case undergoing fracture in the cervical area of the root (at the CEJ) and another with a horizontal root fracture (Fig. 5). In the zirconia post-and-core group, the root fracture was observed in 10 samples (83.3%), of which the apical 2 mm of the post
