The effect of various veneering techniques on the marginal fit of zirconia copings

PURPOSE. This study aimed to evaluate the fit of zirconia ceramics before and after veneering, using 3 different veneering processes (layering, press-over, and CAD-on techniques). **MATERIALS AND METHODS.** Thirty standardized zirconia CAD/CAM frameworks were constructed and divided into three groups of 10 each. The first group was veneered using the traditional layering technique. Press-over and CAD-on techniques were used to veneer second and third groups. The marginal gap of specimens was measured before and after veneering process at 18 sites on the master die using a digital microscope. Paired t-test was used to evaluate mean marginal gap changes. One-way ANOVA and post hoc tests were also employed for comparison among 3 groups ($\alpha=.05$). **RESULTS.** Marginal gap of 3 groups was increased after porcelain veneering. The mean marginal gap values after veneering in the layering group (63.06 μm) was higher than press-over (50.64 μm) and CAD-on (51.50 μm) veneered groups ($P<.001$). **CONCLUSION.** Three veneering methods altered the marginal fit of zirconia copings. Conventional layering tech

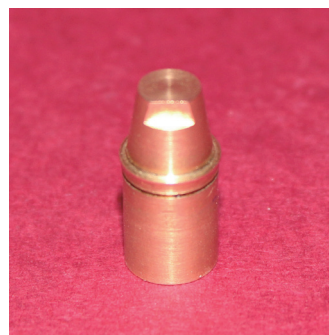
Fig. 1. Brass master die.

Ceramic materials investigated in this study were displayed in Table 1. A brass master die was machined to approximate dimension of a prepared molar for an all ceramic restoration with 7 mm height, 6 degree of occlusal convergence and a 90 degree shoulder of 1 mm wide finish line (Fig. 1). Preparation of master die was free of any irregular-

ities, and was done in accordance with the current standards of full ceramic restorations.³² An antirotational design was included in the axial surface to ensure reproducible seating of the coping on the master die. Eighteen points for measurement of vertical marginal gap at 20 degree intervals were marked on a groove 3 mm below the margin by means of a high speed handpiece and a diamond needle bur. Finally, the die was embedded in an acrylic block by means of a dental surveyor (Ney Dental Surveyor, Dentsply, Balgates, Switzerland) to ensure its long axis was perpendicular to the horizontal plane.

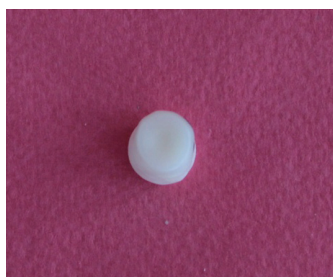
Fig. 2. Fabricated zirconia CAD/CAM coping.

In order to eliminate the effect of impression and pouring variations, the metallic die was used as the definitive die. The die was sprayed with scan spray and scanned using a 3D-laser scanner (3ShapeD810; 3Shape, Copenhagen K, Denmark). The data were transferred to CAD software (3Shape's CAD Design software; 3Shape, Copenhagen K, Denmark) in which the copings were designed with a uniform thickness of 0.5 mm around, considering 30 μ m spacer, and 1 mm short of the margin. In the occlusal surface a depression was designed to accommodate the tip of the holding device (Fig. 2). Thirty zirconia copings were milled from pre-sintered Y-TZP blanks (IPS e.max ZirCAD, Ivoclar Vivadent) in a milling machine (inLab MC XL, Sirona) in a

white state. The zirconia frameworks were then sintered (Programat S1, Ivoclar Vivadent). The frameworks were examined for any imperfections and rejected if any deformation was observed.

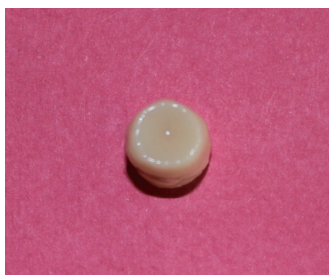
Fig. 5. Fabricated zirconia CAD/CAM crown.

Thirty copings were randomly divided into 3 equal groups. On each of them one of the following veneering techniques were performed (layering (L), press-over (P), and CAD-on (C) techniques). The first 10 copings were veneered using the traditional layering technique. A silicone index was used to standardize the shape and size of veneers with a homogenous veneering thickness of range between 0.7 mm at margins and 1.5 mm at occlusal surfaces. To veneer the copings with layering technique, the liner (IPS e.max, zirlliner; Ivoclar Vivadent) was applied to the zirconia copings, and they fired in a compatible ceramic furnace (Programmat 700; Ivoclar Vivadent) at 960°C; then a nano-fluoroapatite glass ceramic (IPS e.max Ceram; Ivoclar Vivadent) was applied in dentin and enamel layers and processed at 750°C, followed by glazing and finishing procedures to complete the restorations. The occlusal surface of the crowns was accommodated to the holding device tip to

ensure the same seating of them as copings on the die (Fig. 5).
