Research Article

Microtensile bond strength of CAD/CAM-fabricated polymer-ceramics to different adhesive resin cements

Objectives: This study evaluated the microtensile bond strength (μ TBS) of polymer-ceramic and indirect composite resin with 3 classes of resin cements.

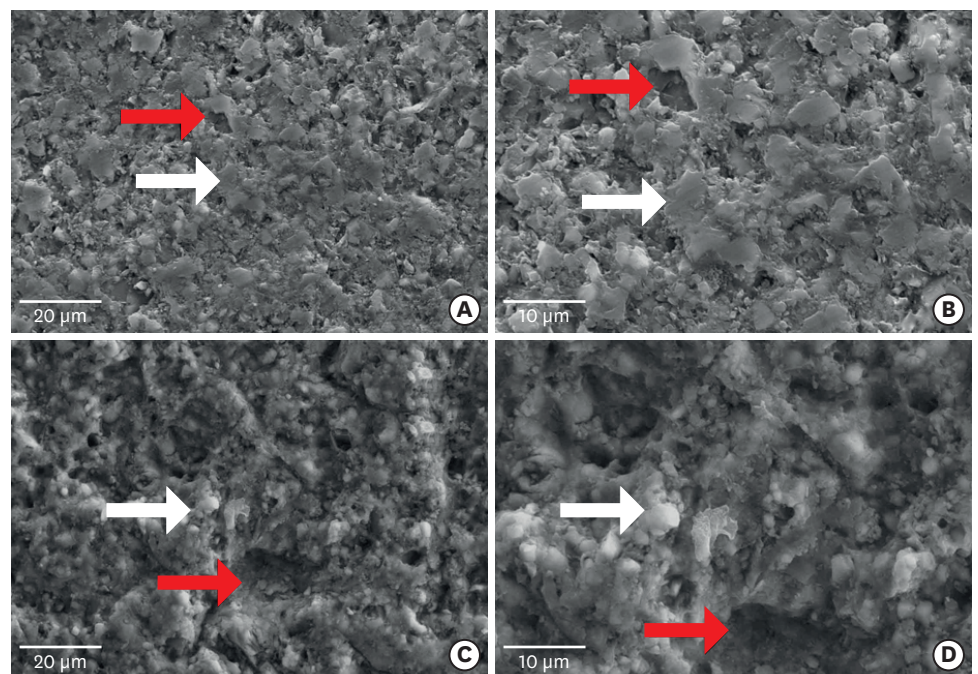
Figure 1. Scanning electron microscope images of computer-aided design/computer-aided manufacturing polymer ceramics before cutting. (A) Enamic ($\times 2,500$) showed a homogeneous distribution of the ceramic phase (white arrow) and the polymer phase (red arrow); (B) With higher magnification ($\times 5,000$), the ceramic particles with sharp edges (white arrow) and amorphous polymer phases (red arrow) were displayed; (C) LAVA Ultimate ($\times 2,500$) showed distributed roughness on the surface; (D) With higher magnification ($\times 5,000$), organic fibers (white arrow) embedded in the polymer matrix were observed.

In the SEM observations of ENA blocks with no treatment, distinct and homogeneous ceramic and polymer phases with micropores of different sizes were observed (**Figure 1A and 1B**). Increased roughness and debris and/or smears were observed after cutting ENA blocks (**Figure 2A and 2B**). The HF-treated ENA specimens were more homogenous than the cut specimens (**Figure 3A and 3B**). The LAV block specimen was rougher than the ENA block specimen. Ceramic particles were uniformly intermingled with the polymer matrix, and distributed porosity was seen over the entire surface of the LAV block (**Figure 1C and 1D**). Decreased roughness and some round holes were observed after the LAV block was cut (**Figure 2C and 2D**). Sandblasting increased the surface roughness, porosity, and presence of round holes. In several areas, the polymer was separated from the surrounding ceramic particles (**Figure 3C and 3D**).

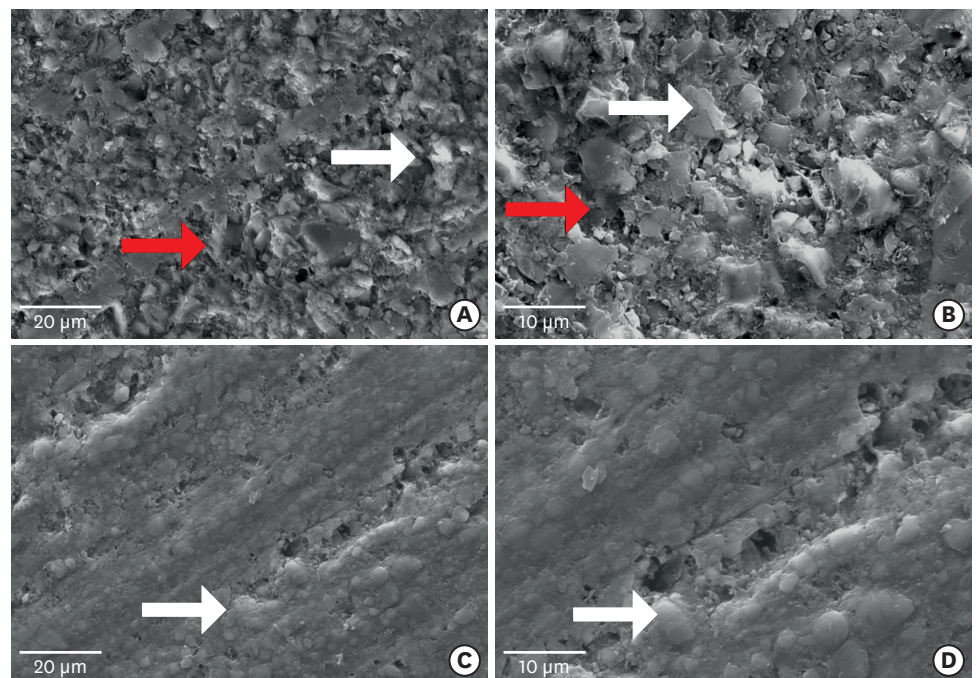
Figure 2. Scanning electron microscope images of computer-aided design/computer-aided manufacturing polymer ceramics after cutting. (A) Enamic ($\times 2,500$); (B) With higher magnification ($\times 5,000$), more roughness than in the as-block specimen was seen (white arrow indicates ceramic particles and red arrow indicates polymer phase); (C) LAVA Ultimate ($\times 2,500$); (D) With higher magnification ($\times 5,000$), the cut surface of Lava Ultimate showed less roughness. More areas of porosity were distributed across the specimen than in the as-block specimen (whiter arrow indicates ceramic fiber).

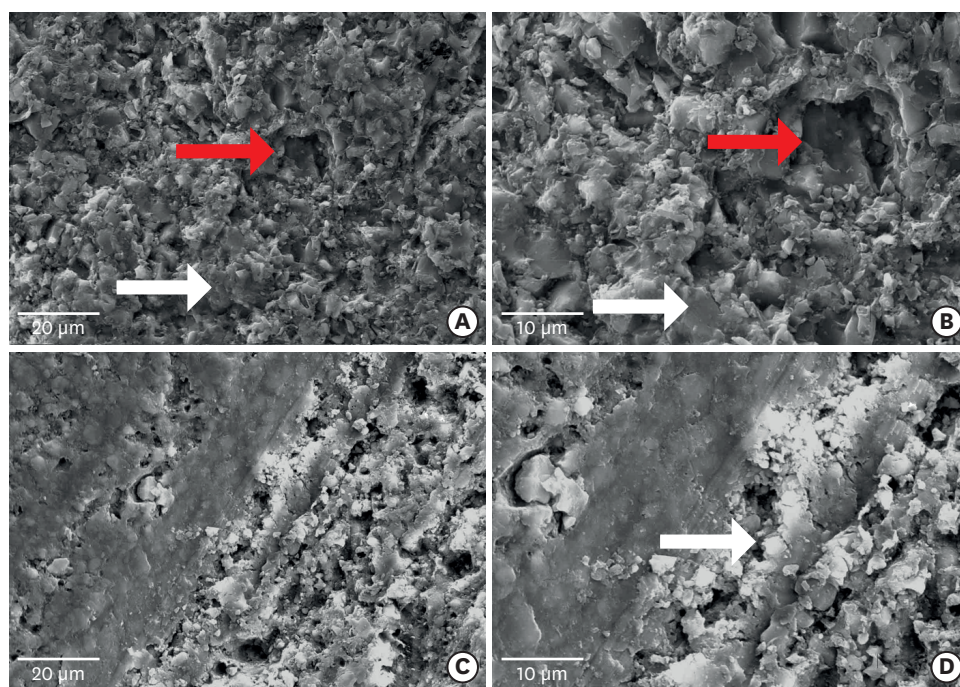
Figure 3. Scanning electron microscope images of computer-aided design/computer-aided manufacturing polymer-ceramic after treatment. (A) Etched surface of Enamic ($\times 2,500$); (B) With higher magnification ($\times 5,000$), larger holes (white arrow) within a relatively unaffected polymer phase (red arrow) are seen; (C) Lava Ultimate after sand blasting ($\times 2,500$); (D) With higher magnification ($\times 5,000$), Lava Ultimate showed more roughness and porosity than untreated specimens. The cracks in the matrix could be seen (white arrow).
